Tree Evaluation Report

Ramos and V Tree Service

Kelly Borbon
35 Limestone Road
Armonk, N.Y. 10504

November 12, 2022

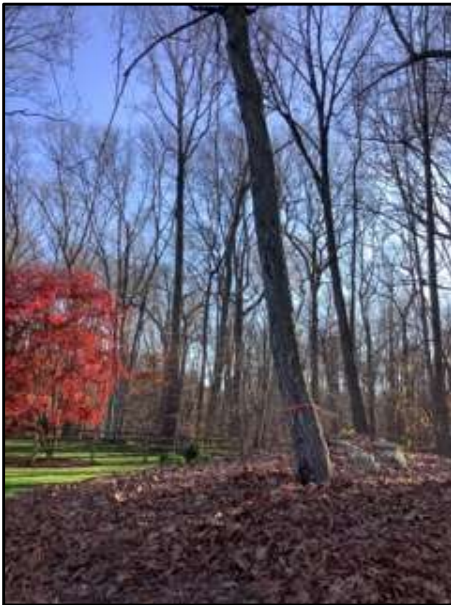
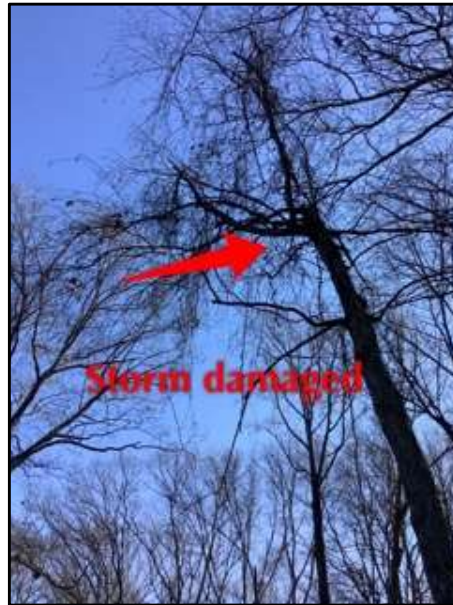
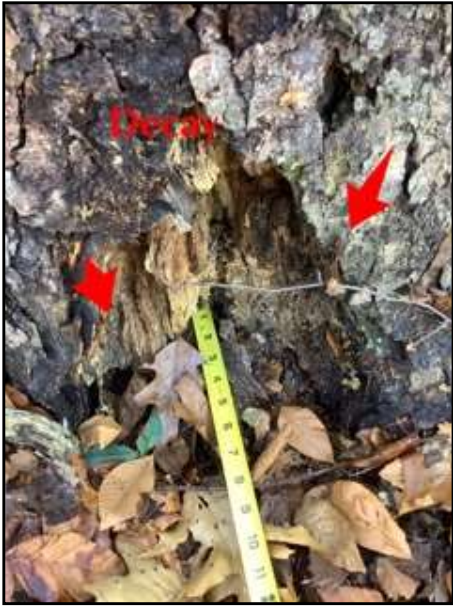
Location:	Side yard left
Species:	Black cherry
Invasive:	No
Diameter Breast Height:	14
Crown Width:	30
General Appearance:	51 to 75% Crown decline
Target:	Road
Soil Conditions:	Rock ledge
Root Flare:	Cavity
Trunk:	Cavity, Decay
Root Zone:	Mushrooms / decay fungi
Recommendation:	Remove tree

Cherry with lean next to driveway. Root flare has significant decay and rot, tape measure was inserted 6 inches into trunk. Crown is storm damaged and has decay and rot throughout. Tree is structurally unstable and failure at root flare will occur.

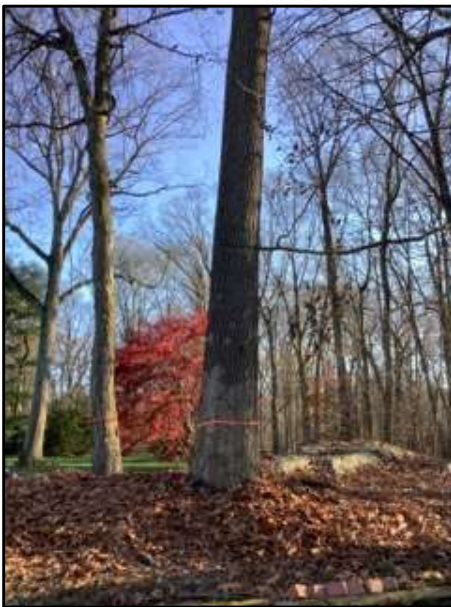
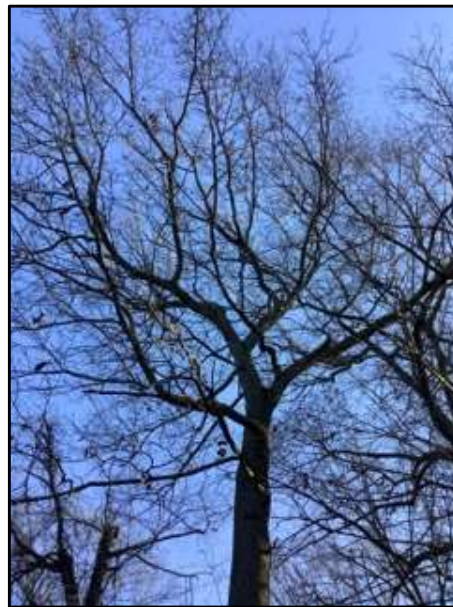
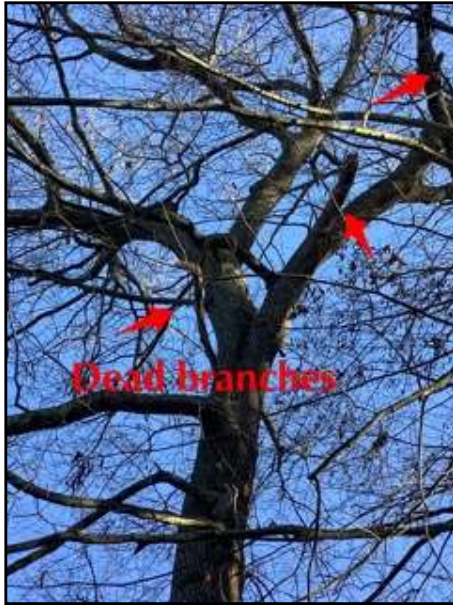
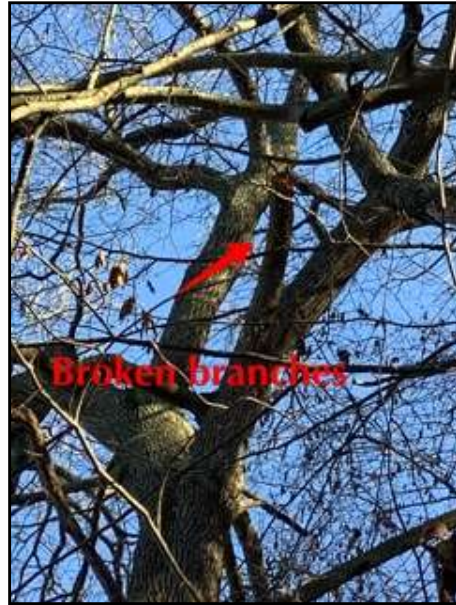
Location:	Side yard left
Species:	Oak
Invasive:	No
Diameter Breast Height:	28
Crown Width:	60
General Appearance:	0 to 25% Crown decline
Target:	Home
Soil Conditions:	Natural grade, Rock ledge
Root Flare:	Ok
Trunk:	No damage
Root Zone:	Elevated root zone
Recommendation:	Home owner requesting removal

Oak tree on side of driveway has numerous branches in decline that have failed. Due to acorns falling onto cars parked adjacent to driveway and damage to vehicle removal is being requested.

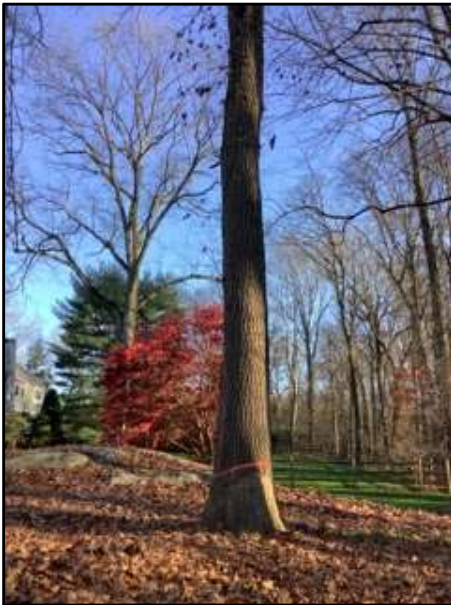
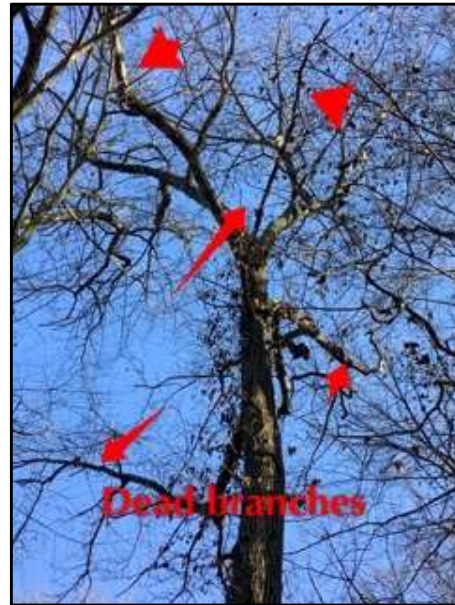
Location:	Rear left
Species:	Oak
Invasive:	No
Diameter Breast Height:	24
Crown Width:	80
General Appearance:	26 to 50% Crown decline
Target:	Home
Soil Conditions:	Natural grade
Root Flare:	Ok
Trunk:	No damage
Root Zone:	Ok
Recommendation:	Homeowner requests removal

Oak has 30 percent of crown in decline with numerous dead branches. Trimming of tree alone will leave it unbalanced and will remove more than the typically allowed 25 percent.

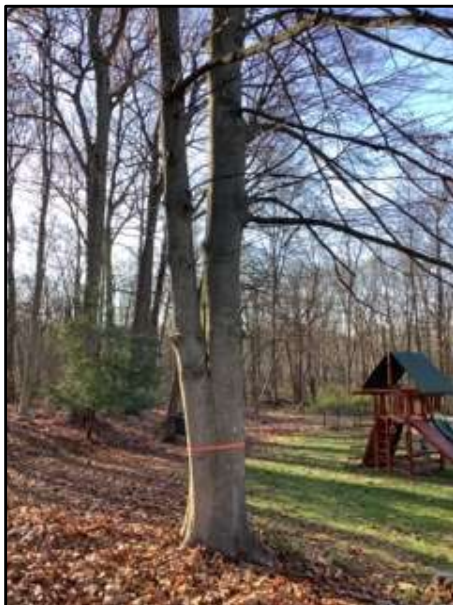
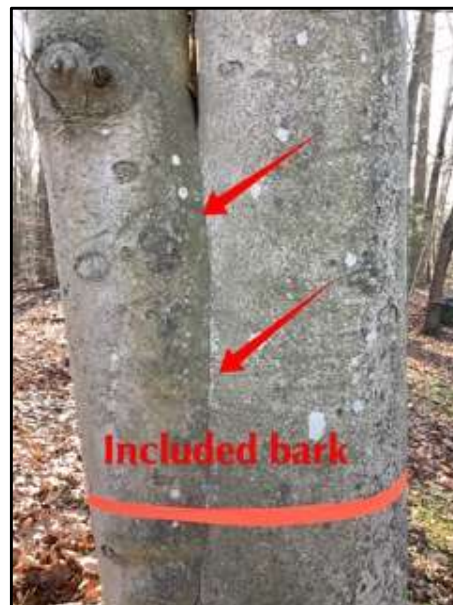
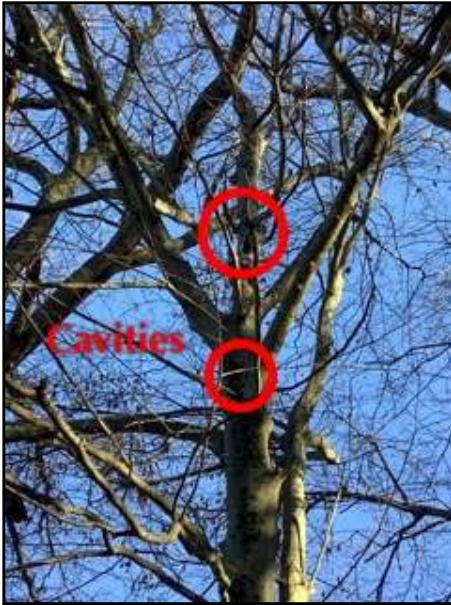
Location:	Rear left
Species:	Beech
Invasive:	No
Diameter Breast Height:	22
Crown Width:	40
General Appearance:	26 to 50% Crown decline
Target:	Yard
Soil Conditions:	Natural grade
Root Flare:	Ok
Trunk:	Multi leader
Root Zone:	Ok
Recommendation:	Homeowner requests removal

Beech tree with co dominant leaders has included bark in crotch area, such is subjects to decay, or and splitting. Upper crown has numerous cavities in branches. Trimming would leave tree weighted to one side and upper crown would be topped. With beech leaf disease in area such is not recommended.

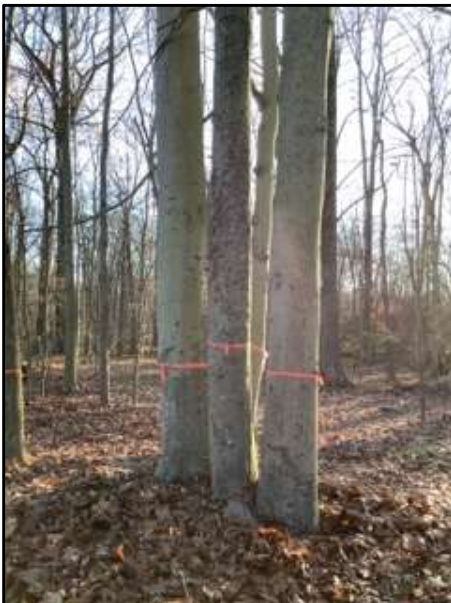
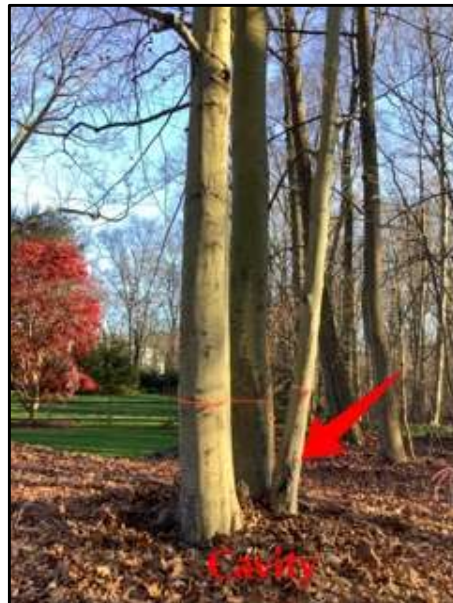
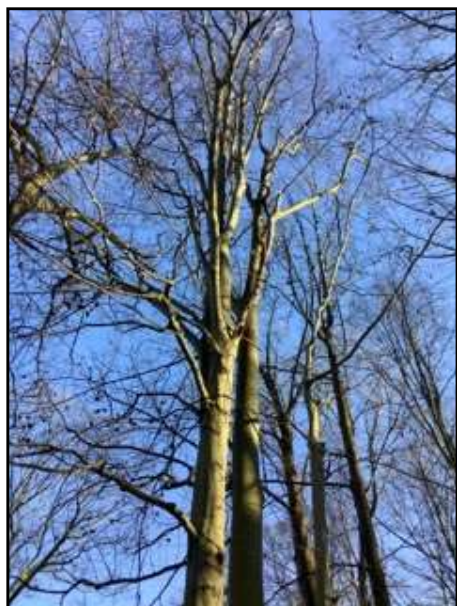
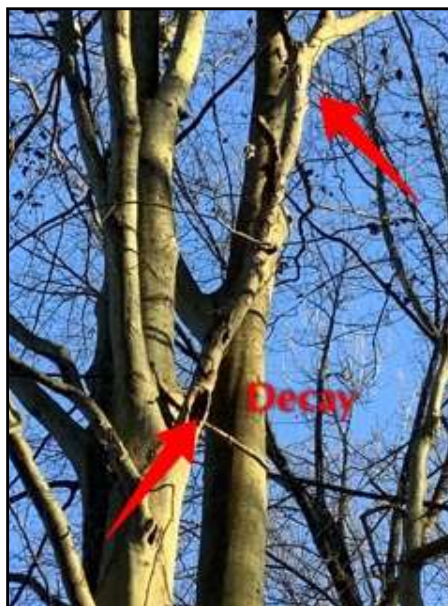
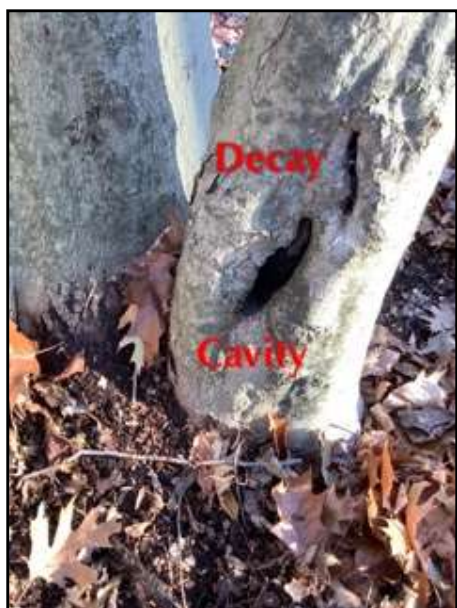
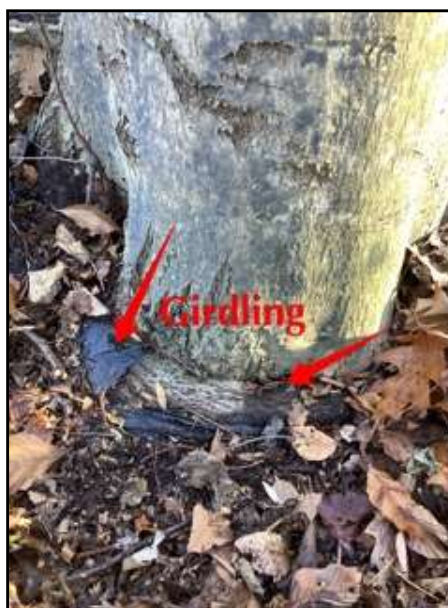
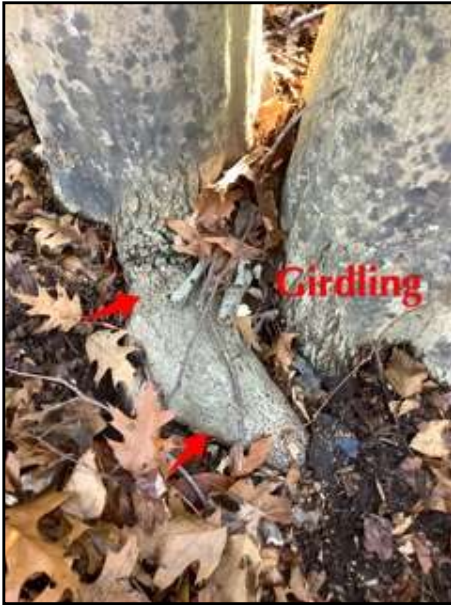
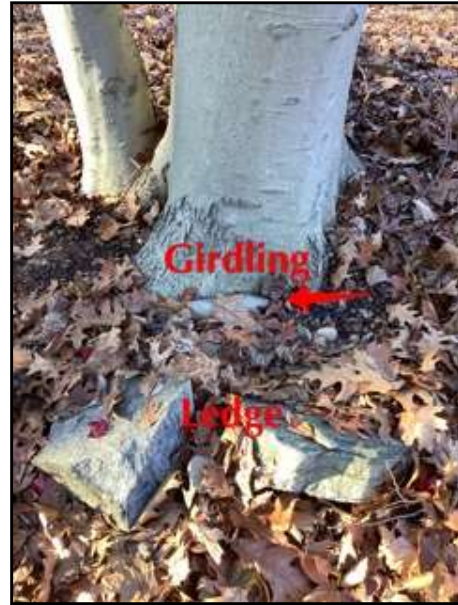
Location:	Rear left
Species:	Beech
Invasive:	No
Diameter Breast Height:	16, 13, 8, 14
Crown Width:	50
General Appearance:	0 to 25% Crown decline
Target:	Yard
Soil Conditions:	Natural grade
Root Flare:	Cavity, Girdling
Trunk:	No damage
Root Zone:	Girdling, Hollow base
Recommendation:	Remove tree

Clump of beech trees with girdled root flares. Single 8 inch tree is hollow at base and has decay in crown. Clump of trees is growing on an elevated rock ledge and root zone is questionable. Removal of 8 inch tree will open the group to decay and rot at root flare. Three of the larger trees have significant girdling roots that encircle the basal flare area of the trees. This knot like effect is choking the trees and is further leaving the trees to decay and rot around the root flare region.

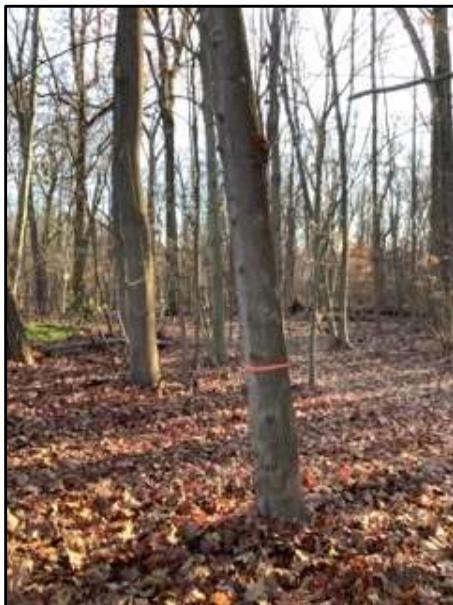
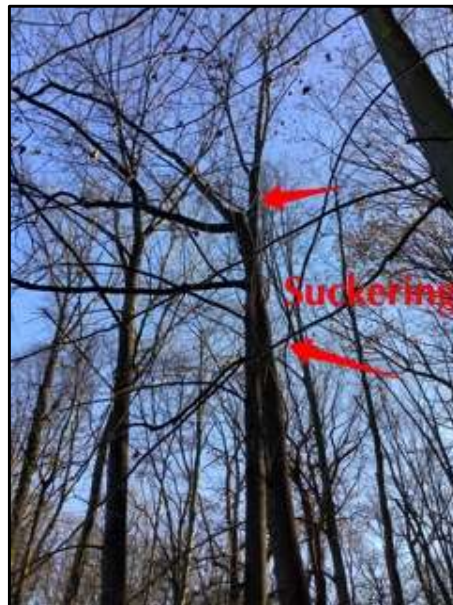
Location:	Rear left
Species:	Oak
Invasive:	No
Diameter Breast Height:	8
Crown Width:	20
General Appearance:	0 to 25% Crown decline
Target:	Yard
Soil Conditions:	Natural grade
Root Flare:	Ok
Trunk:	Lean
Root Zone:	Ok
Recommendation:	Remove tree

Oak in rear left yard is untypical in growth pattern and has significant suckering. Tree is reaching to external influences and is suckering, these suckers are dominant and will create weak wooded branches that will be subject to failure. Tree due to growth habit will further grow in a unsafe fashion.

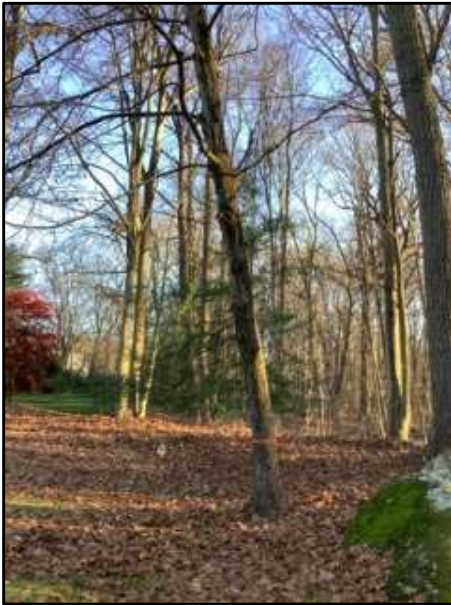
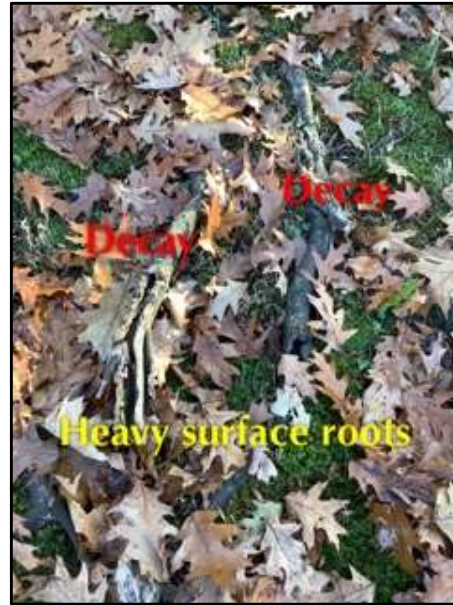
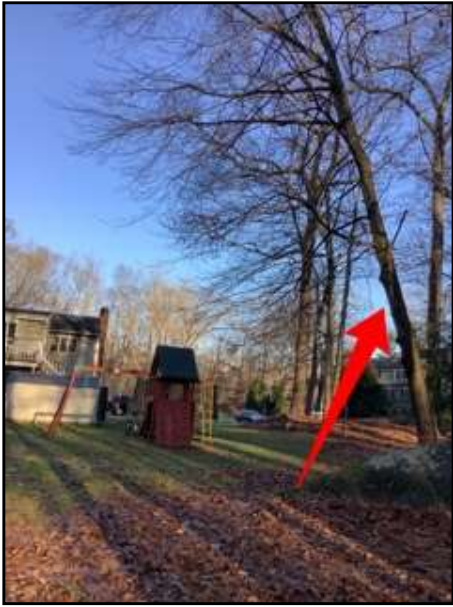
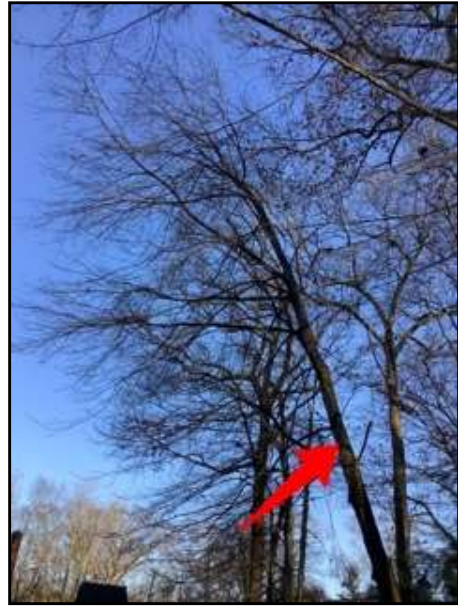
Location:	Rear left
Species:	Ash
Invasive:	No
Diameter Breast Height:	8
Crown Width:	40
General Appearance:	0 to 25% Crown decline
Target:	Swings
Soil Conditions:	Natural grade
Root Flare:	Heavy surface rooting
Trunk:	Lean
Root Zone:	Impacted
Recommendation:	Remove tree

Ash in rear yard is leaning over swing set. Swings are used by children routinely. Tree has heavy surface roots in rear yard which are decayed and deteriorating. Tree is weighted to swing set side and failure will be catastrophic. Major concern is regarding the root rot of the surface roots. Surface roots further pose trip hazard in the yard.

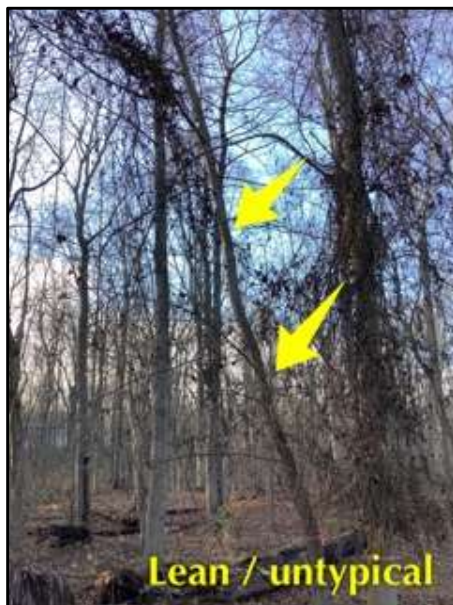
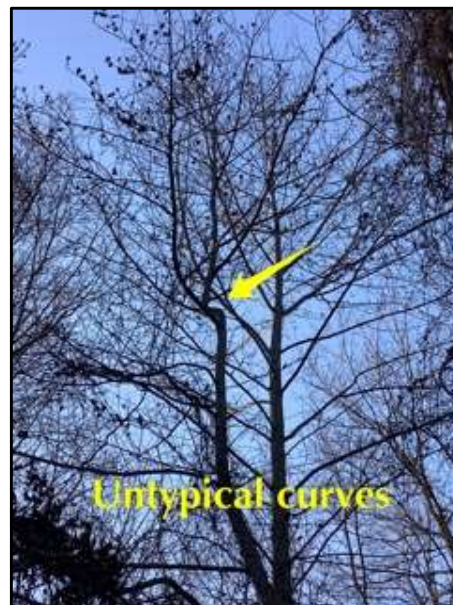
Location:	Rear right
Species:	Ash
Invasive:	No
Diameter Breast Height:	7
Crown Width:	10
General Appearance:	0 to 25% Crown decline
Target:	Yard
Soil Conditions:	Natural grade
Root Flare:	Ok
Trunk:	Untypical pattern
Root Zone:	Ok
Recommendation:	Remove tree

Ash tree has untypical curves to trunk and as a result is predisposed to failure. Ash is also subject to Emerald ash borer and removal at this time is warranted. The trunk has a 25 degree lean to it, while in upper crown the trunk makes almost a Z turn.

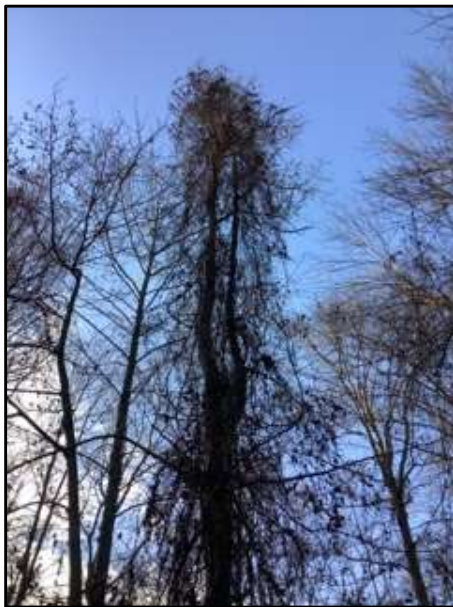
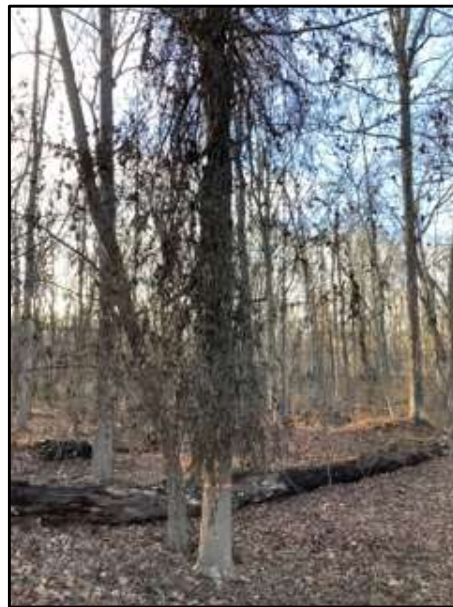
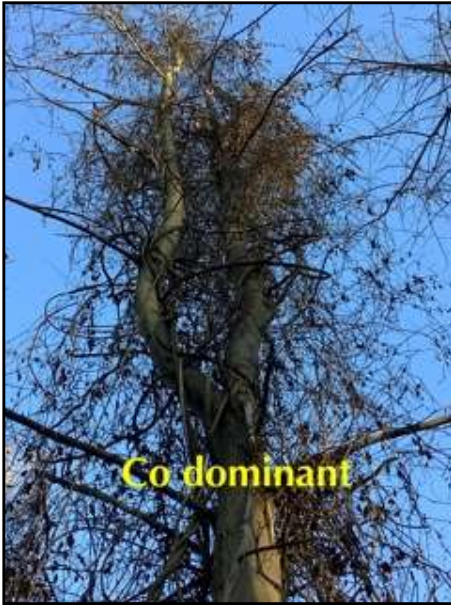
Location:	Rear right
Species:	Ash
Invasive:	No
Diameter Breast Height:	12
Crown Width:	20
General Appearance:	0 to 25% Crown decline
Target:	Shed , Yard
Soil Conditions:	Natural grade
Root Flare:	Ok
Trunk:	Co dominant
Root Zone:	Ok
Recommendation:	Remove tree

Co dominant ash tree in rear severely damaged from vines. Untypical branch habit in crown will cause single leader to snap from weight and winds. Due to Emerald Ash borers in area removal is warranted.

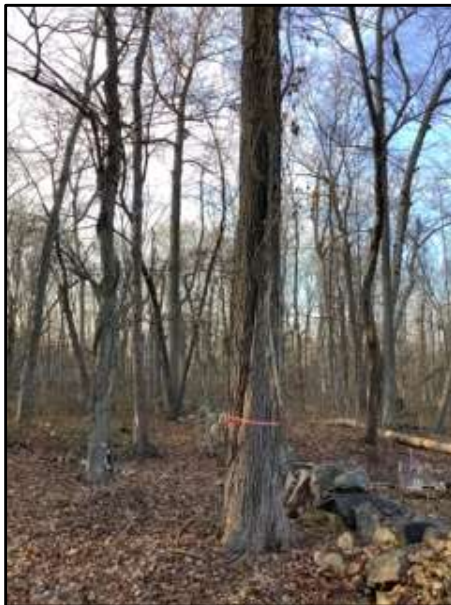
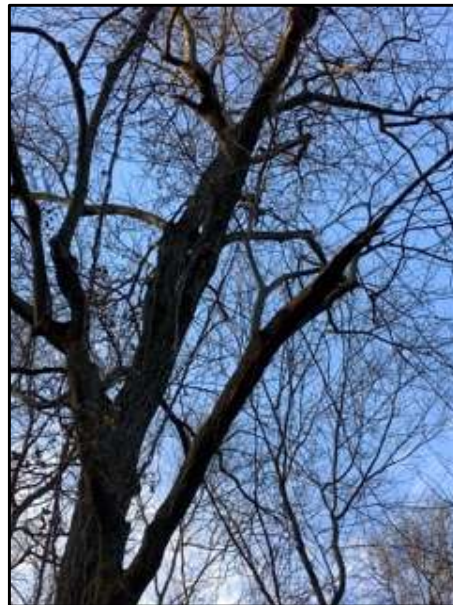
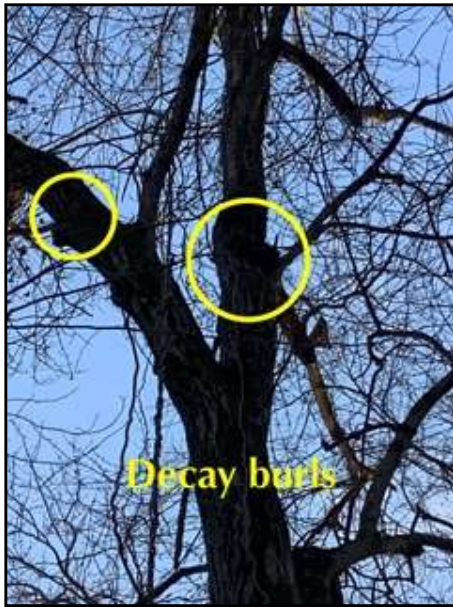
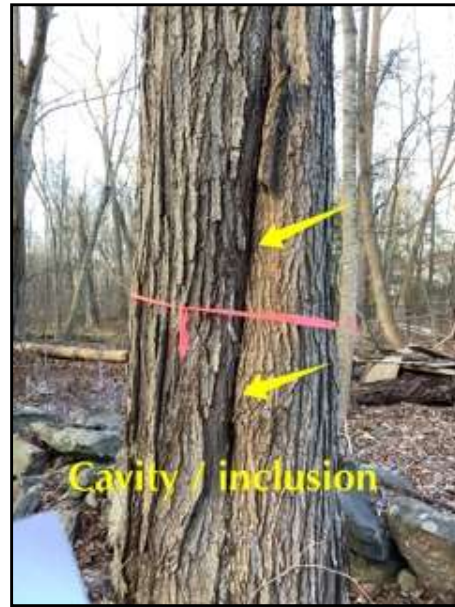
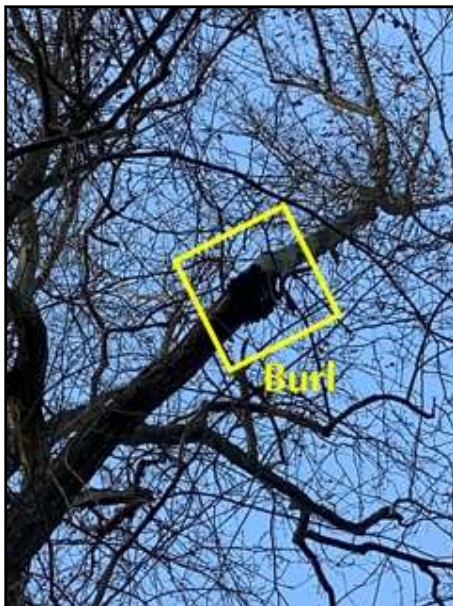
Location:	Rear right
Species:	Hickory
Invasive:	No
Diameter Breast Height:	18
Crown Width:	60
General Appearance:	26 to 50% Crown decline
Target:	Neighbors yard
Soil Conditions:	Natural grade
Root Flare:	Ok
Trunk:	Cavity, Decay, Disease visible
Root Zone:	Ok
Recommendation:	Remove tree

Hickory in rear right corner has a 4 foot long inclusion in the trunk area that is subject and indicative of decay and rot, potential cavity. Upper crown has past storm damage and burls indicative of decay fungi. There are 3 distinctive burls in upper crown. Burls are areas that are infected by a bacterial infection and are subject to decay and rot over time.

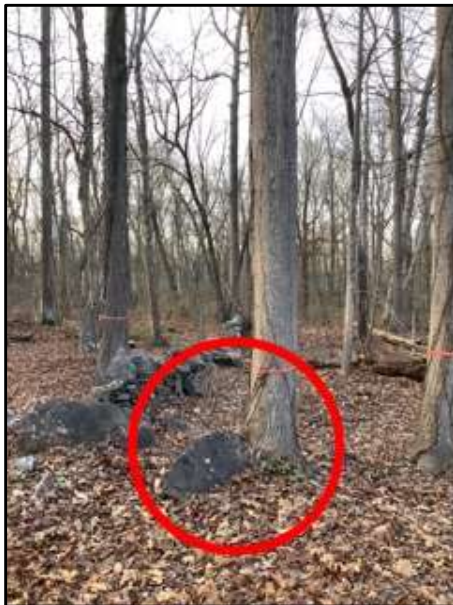
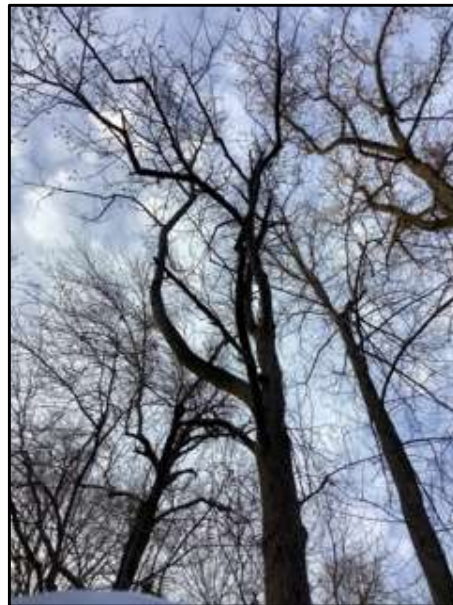
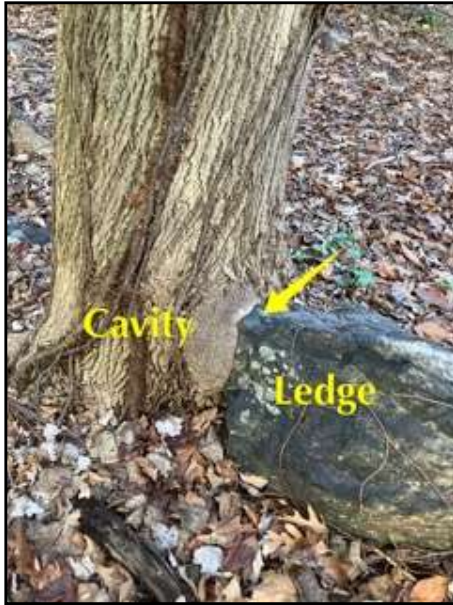
Location:	Rear right
Species:	Tulip
Invasive:	No
Diameter Breast Height:	12
Crown Width:	50
General Appearance:	26 to 50% Crown decline
Target:	Yard
Soil Conditions:	Natural grade
Root Flare:	Cavity, Rock ledge
Trunk:	Cavity, Decay
Root Zone:	Ok
Recommendation:	Remove tree

Tulip has a significant rock growing out of the basal flare region. Being the tree is a Poplar it is fast growing, weak wooded and easily subjected to decay and rot. Upper crown has been storm damaged and has bark separation visible. Upper crown is one sided and weighted towards pool cabana building. The impact of the rock on the root flare is extensive as it encompasses approximately 1/3 of the basal region.

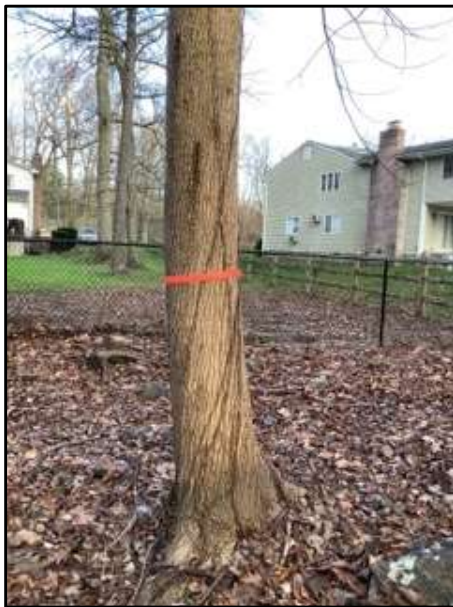
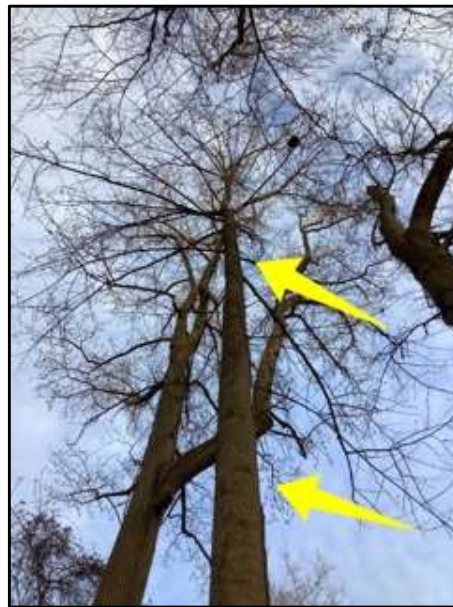
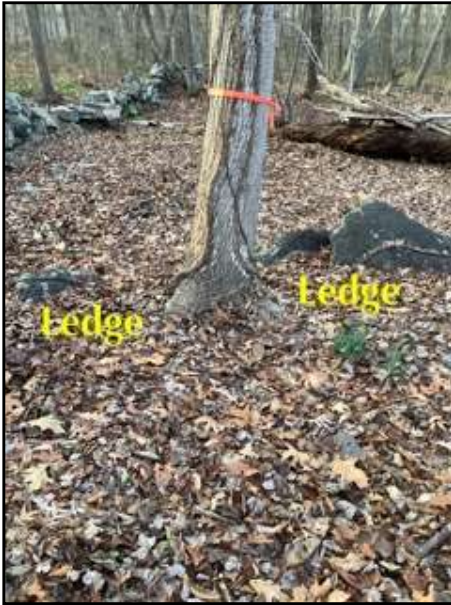
Location:	Rear right
Species:	Tulip
Invasive:	No
Diameter Breast Height:	8
Crown Width:	50
General Appearance:	26 to 50% Crown decline
Target:	Yard
Soil Conditions:	Rock ledge
Root Flare:	Ok
Trunk:	No damage
Root Zone:	Ok
Recommendation:	Remove tree, Homeowner requests removal

Tulip is part of a cluster and protected by other trees. If left, this tree will be subjected to full wind loads and subject to wind throw. Trunk is within a rock ledge area and root zone is questionable.

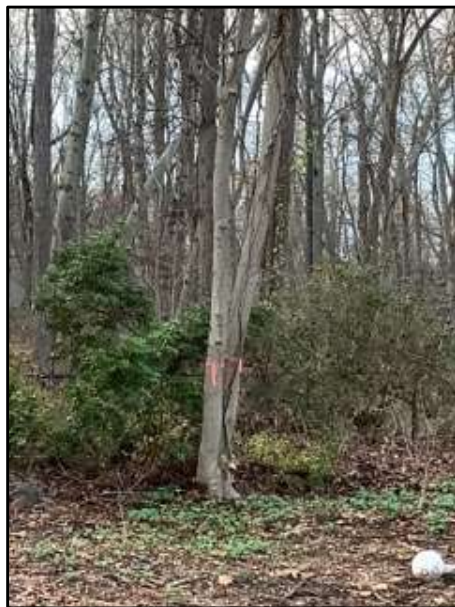
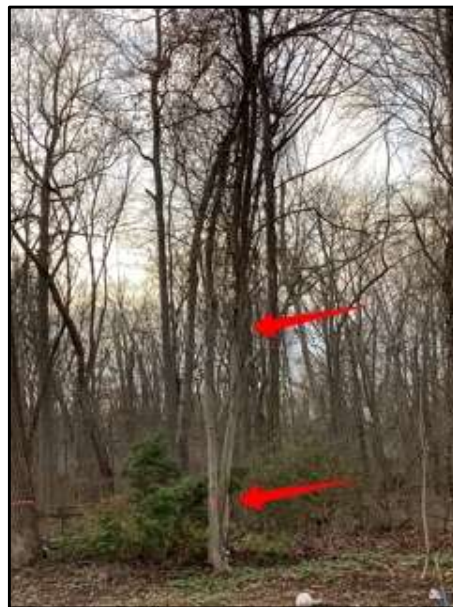
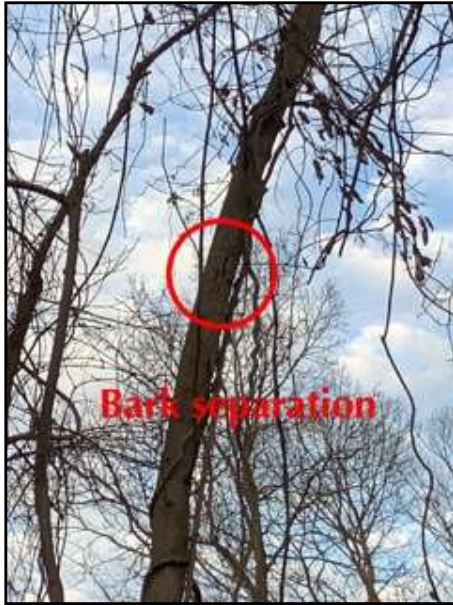
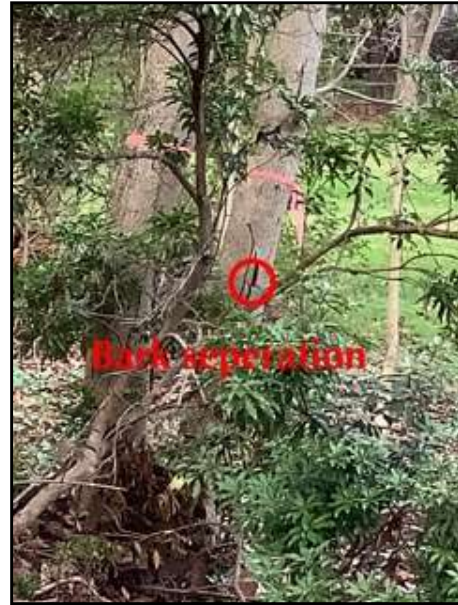
Location:	Rear right
Species:	Ash
Invasive:	No
Diameter Breast Height:	4, 4
Crown Width:	20
General Appearance:	0 to 25% Crown decline, 26 to 50% Crown decline
Target:	Rear yard
Soil Conditions:	Natural grade
Root Flare:	Ok
Trunk:	Bark separation, Co dominant
Root Zone:	Ok
Recommendation:	Remove tree

Co dominant ash tree. Subject to Emerald Ash Borers. Poor growth habits. Bark separation visible on rear trunk.

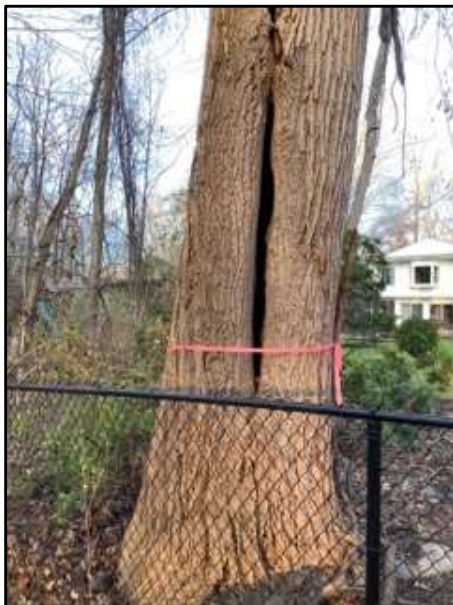
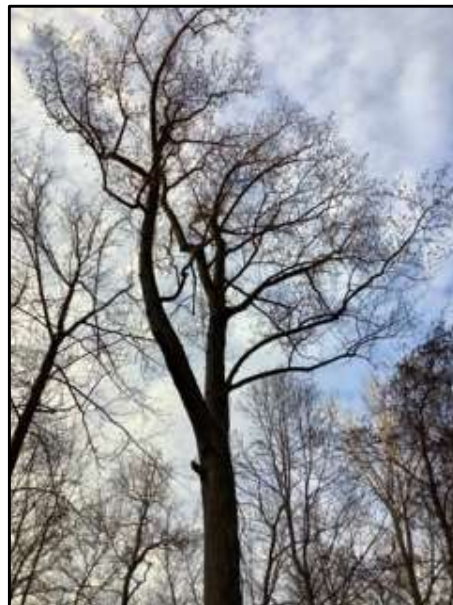
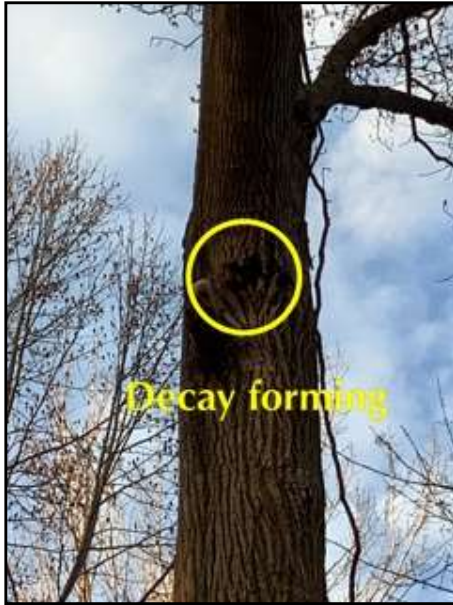
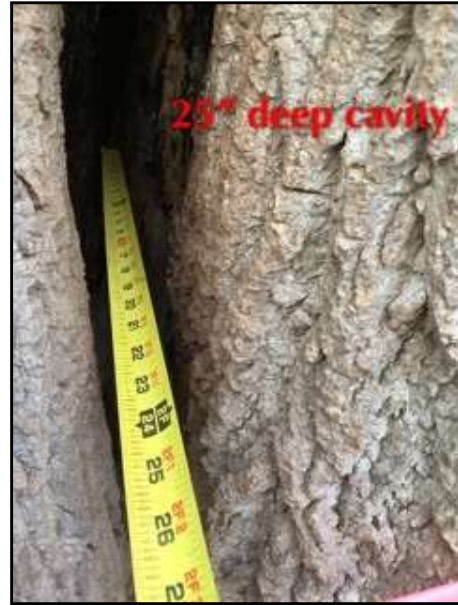
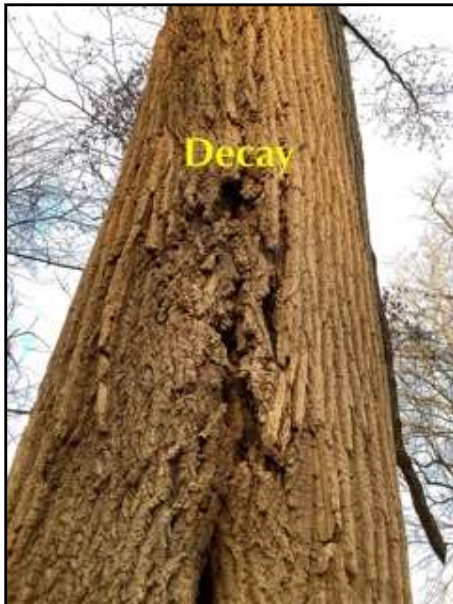
Location:	Rear right
Species:	Tulip
Invasive:	No
Diameter Breast Height:	29
Crown Width:	80
General Appearance:	0 to 25% Crown decline
Target:	Houses
Soil Conditions:	Natural grade
Root Flare:	Ok
Trunk:	Cavity, Decay, Cracked, Multiple cavities, Structurally unsafe
Root Zone:	Ok
Recommendation:	Remove tree, Expedited removal

Tulip in rear right corner has structural decay and is in a severe state. Immediate removal is recommended. Cavity is 25 inches deep and approximately 15 feet high. Upper 24 inch leader has decay starting at underside of union.

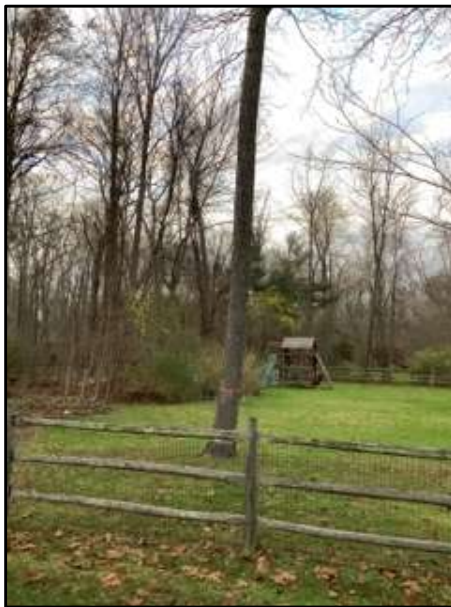
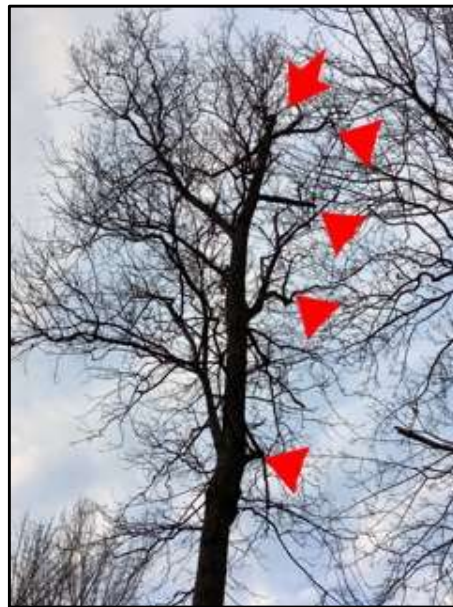
Location:	Side yard right
Species:	Oak
Invasive:	No
Diameter Breast Height:	12
Crown Width:	60
General Appearance:	26 to 50% Crown decline
Target:	Home
Soil Conditions:	Natural grade
Root Flare:	Ok
Trunk:	No damage
Root Zone:	Ok
Recommendation:	Remove tree, Homeowner requests removal

Oak has numerous heading cuts made years ago. Crown is disfigured and wounds are not compartmentalizing. Tree decay is beginning in these cuts. Numerous dead branches are visible and removal is such will leave 30 percent crown only.

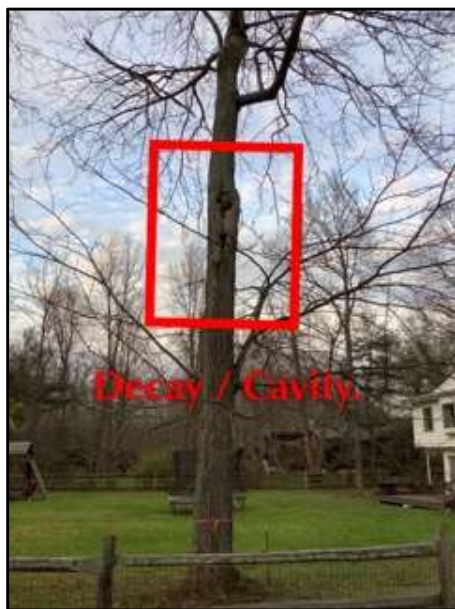
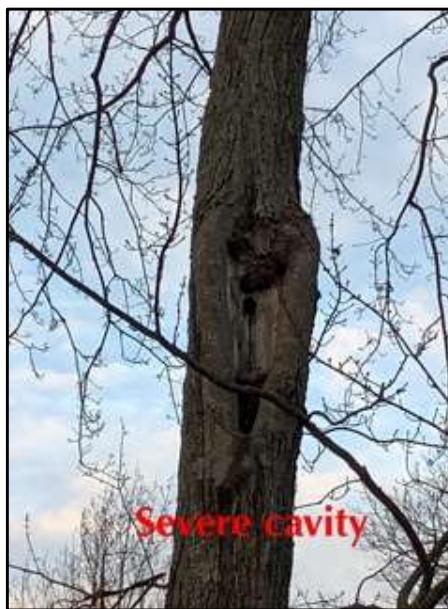
Location:	Side yard right
Species:	Maple
Invasive:	No
Diameter Breast Height:	24
Crown Width:	60
General Appearance:	0 to 25% Crown decline, Buds visible
Target:	Homes
Soil Conditions:	Natural grade
Root Flare:	Ok
Trunk:	Cavity, Decay, Lean
Root Zone:	Ok
Recommendation:	Remove tree

Maple with structural decay. 8 foot long cavity in trunk at approximately 25 feet. Failure is imminent at this area.

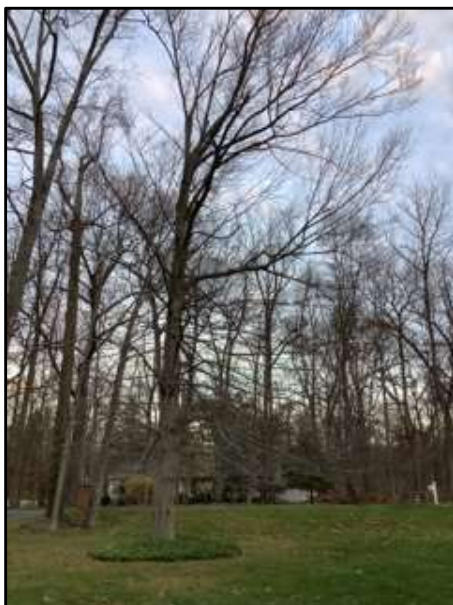
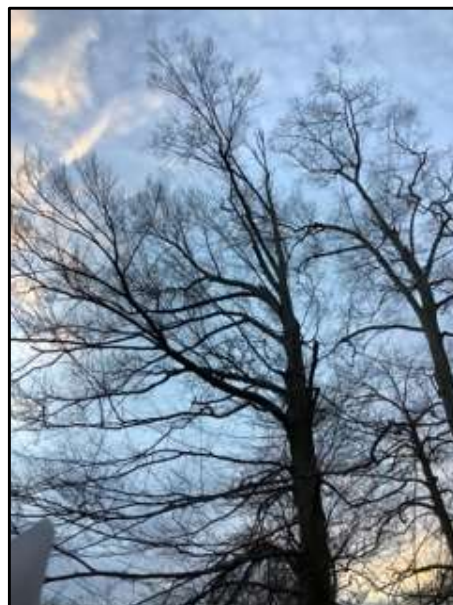
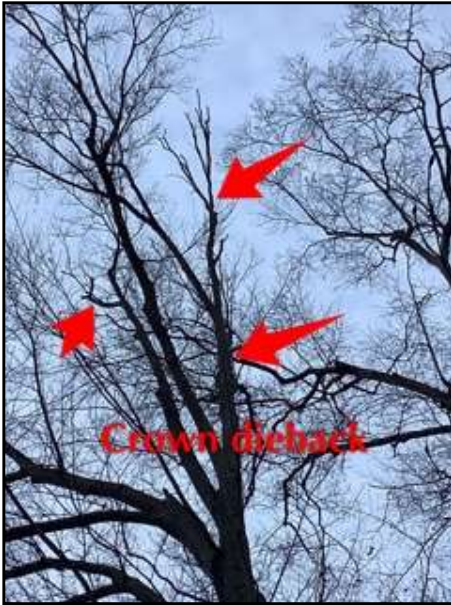
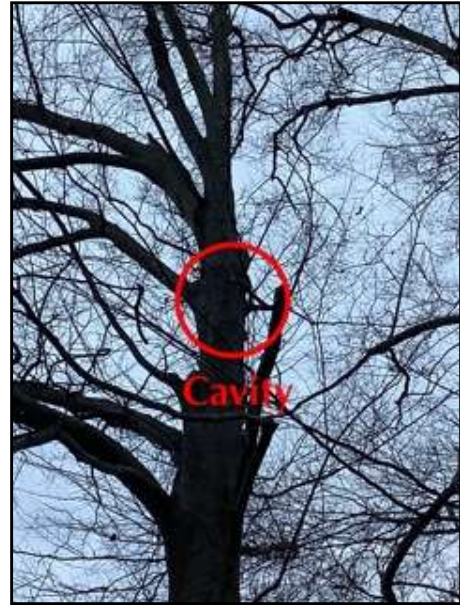
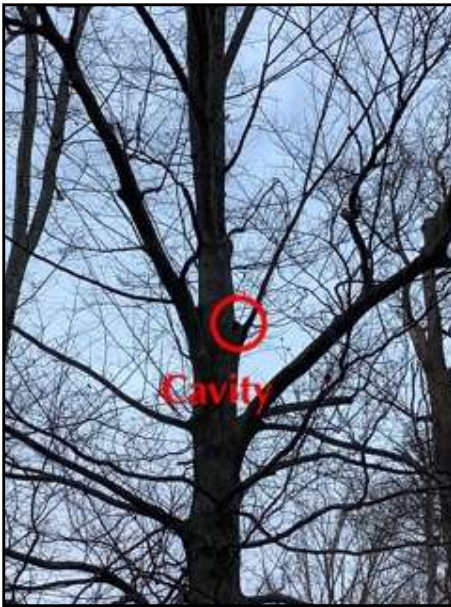
Location:	Front yard right
Species:	Beech
Invasive:	No
Diameter Breast Height:	20
Crown Width:	60
General Appearance:	0 to 25% Crown decline
Target:	Road, Wires
Soil Conditions:	Natural grade
Root Flare:	Ok
Trunk:	Disease visible, Multiple cavities
Root Zone:	Ok
Recommendation:	Remove tree

Beech in front right yard is infected with beech leaf disease. Upper trunk has a cavity at 50 feet just below a crotch on front, and another cavity on rear side just below. Trimming of these cavities will leave tree topped, which is improper. Upper crown is showing bark separation and dieback.
