March 25, 2024

**Re: *8 Cole Drive, Armonk, New York  
Amended Site Plan, Wetlands,  
Steep Slopes and Tree Removal Permits***

C. Trees: The Applicant retained Emerald Tree and Shrub to prepare a comprehensive tree inventory of the 26 trees that are proposed to be removed in connection with this application. Of these 26 trees, 4 are in critical condition, 17 are in poor condition, and 5 are in fair condition.

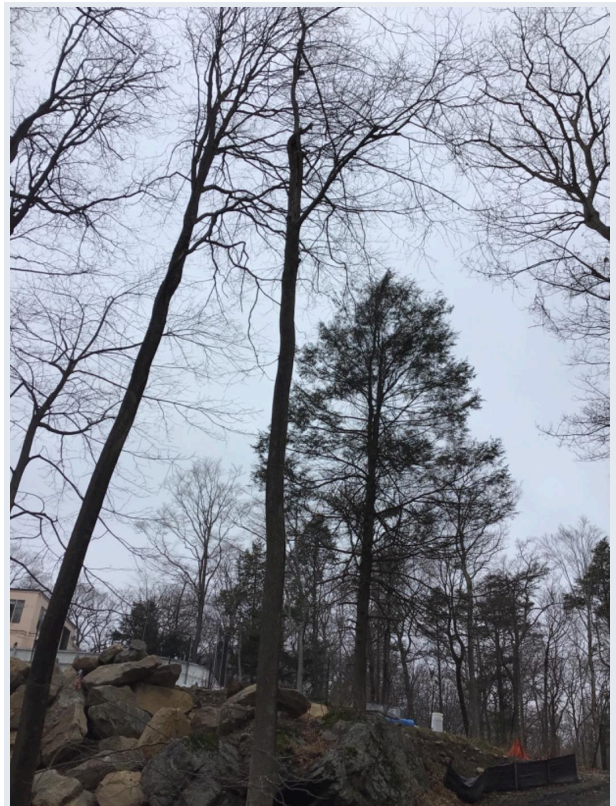
The 4 trees in critical condition have significant visible damage from the Emerald Ash Borer and are no longer viable (Trees 1 and 14), suffer from previous large limb failure and have deadwood throughout the crown (Tree 8), or have exposed roots and basal cavity present where the tree is rooted on rock (Tree 20).

Scientific Name:	Fraxinus species
Common Name:	Ash
Genus:	Fraxinus
Condition:	20% - Critical
Status:	Alive
Number of Stems (Multi Calc):	1
DBH:	13
DBH Range:	12-18in
Height Range:	50ft-75ft
Risk Rating:	
Priority:	
Crown Spread:	
Canopy Shape:	Asymmetrical
Observations-Characteristics:	Broken Limb, Cavity
Observations-Biotic Pest:	Boring Insect
Observations-Abiotic:	
Notes about tree:	This tree has visible damage from Emerald Ash Borer and is no longer viable.
Tree Work-PHC:	
Tree Work-Other:	
Cycle:	
Last Modified:	02/09/2024
Management Notes:

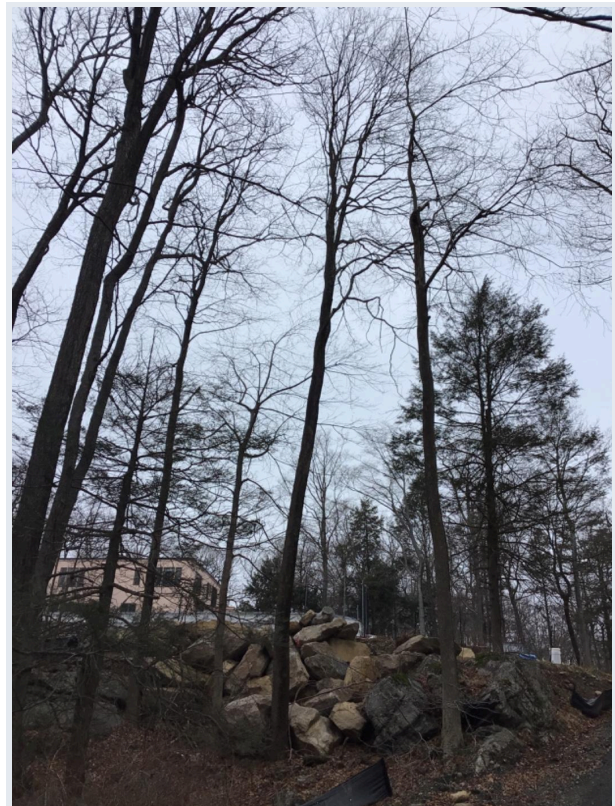
Hickory Tree ID #2

Scientific Name:	Carya species
Common Name:	Hickory
Genus:	Carya
Condition:	60% - Fair
Status:	Alive
Number of Stems (Multi Calc):	1
DBH:	10
DBH Range:	6-12in
Height Range:	30ft-50ft
Risk Rating:	
Priority:	
Crown Spread:	
Canopy Shape:	Asymmetrical
Observations-Characteristics:	
Observations-Biotic Pest:	
Observations-Abiotic:	
Notes about tree:	This tree is in a poor rooting environment.
Tree Work-PHC:	
Tree Work-Other:	
Cycle:	
Last Modified:	02/09/2024
Management Notes:

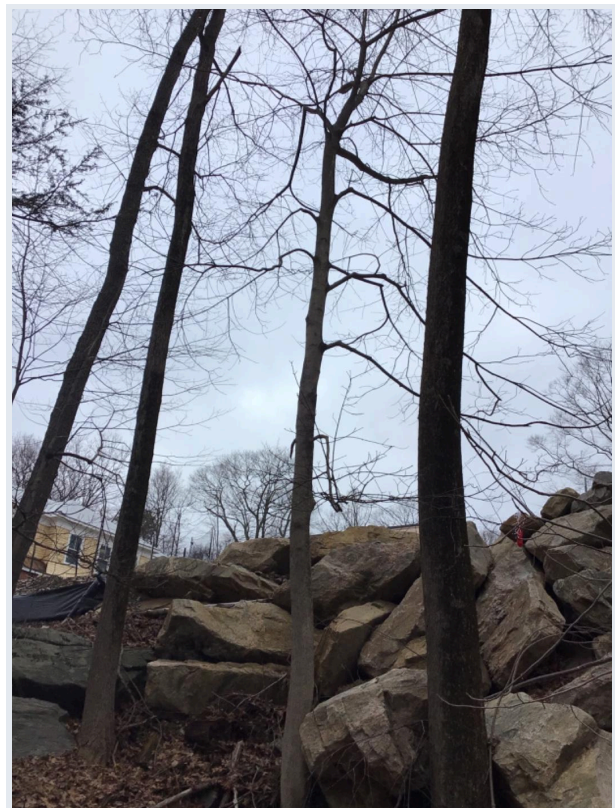
Hickory Tree ID #3

Tree Details	
Scientific Name:	Carya species
Common Name:	Hickory
Genus:	Carya
Condition:	40% - Poor
Status:	Alive
Number of Stems (Multi Calc):	1
DBH:	9
DBH Range:	6-12in
Height Range:	30ft-50ft
Risk Rating:	
Priority:	
Crown Spread:	
Canopy Shape:	Asymmetrical
Observations-Characteristics:	Soil Weakness
Observations-Biotic Pest:	
Observations-Abiotic:	
Notes about tree:	This tree has a limited critical root zone on the rock out crop.
Tree Work-PHC:	
Tree Work-Other:	
Cycle:	
Last Modified:	02/09/2024
Management Notes:

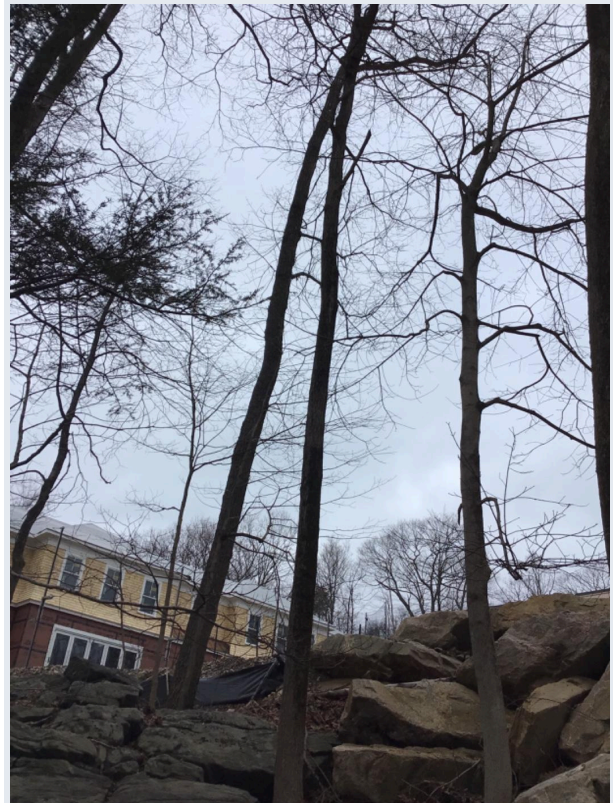
Hickory Tree ID #4

Scientific Name:	Carya species
Common Name:	Hickory
Genus:	Carya
Condition:	40% - Poor
Status:	Alive
Number of Stems (Multi Calc):	1
DBH:	12
DBH Range:	12-18in
Height Range:	30ft-50ft
Risk Rating:	
Priority:	
Crown Spread:	
Canopy Shape:	Asymmetrical
Observations-Characteristics:	Broken Limb
Observations-Biotic Pest:	
Observations-Abiotic:	
Notes about tree:	This tree is in poor condition with a limited critical root zone on the rock outcrop and an asymmetrical crown with deadwood.
Tree Work-PHC:	
Tree Work-Other:	
Cycle:	
Last Modified:	02/09/2024
Management Notes:

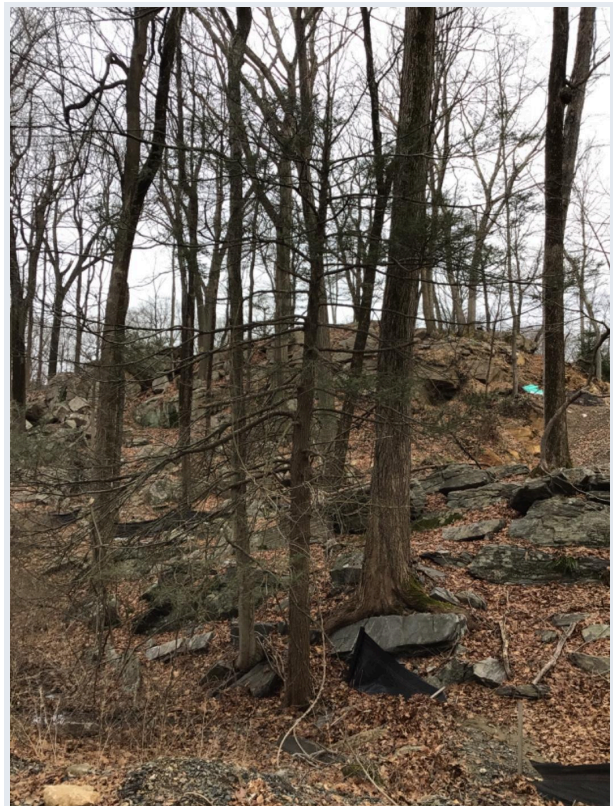
Eastern hemlock Tree ID #5

Scientific Name:	Tsuga canadensis
Common Name:	Eastern hemlock
Genus:	Tsuga
Condition:	40% - Poor
Status:	Alive
Number of Stems (Multi Calc):	1
DBH:	10
DBH Range:	6-12in
Height Range:	15ft-30ft
Risk Rating:	
Priority:	
Crown Spread:	
Canopy Shape:	Asymmetrical
Observations-Characteristics:	Deadwood, Broken Limb
Observations-Biotic Pest:	Leaf feeding Insect
Observations-Abiotic:	
Notes about tree:	Hemlock Enlongate Scale and Woolly Adelgid present. This tree is an extremely poor condition with excessive deadwood throughout the crown.
Tree Work-PHC:	
Tree Work-Other:	
Cycle:	
Last Modified:	02/09/2024
Management Notes:

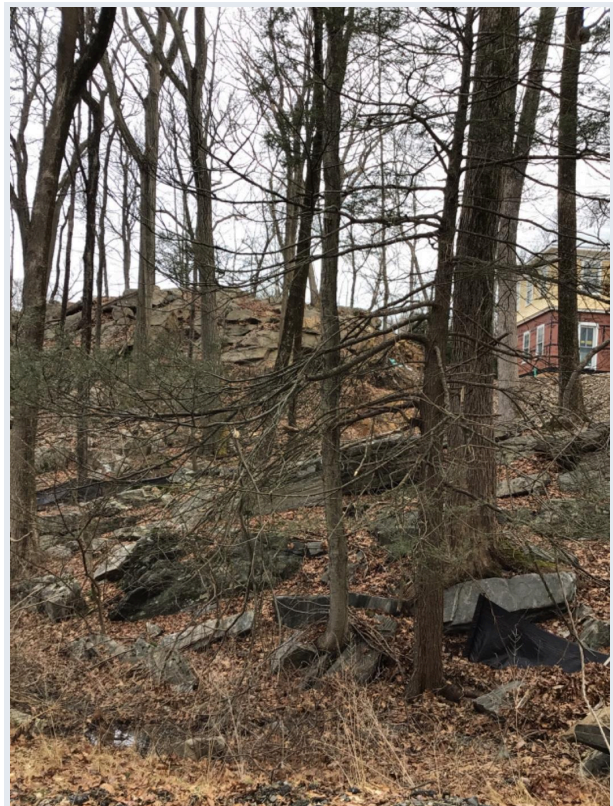
**Black birch Tree ID #6**

Scientific Name:	Betula lenta
Common Name:	Black birch
Genus:	Betula
Condition:	40% - Poor
Status:	Alive
Number of Stems (Multi Calc):	1
DBH:	8
DBH Range:	6-12in
Height Range:	30ft-50ft
Risk Rating:	
Priority:	
Crown Spread:	
Canopy Shape:	Asymmetrical
Observations-Characteristics:	Soil Weakness
Observations-Biotic Pest:	
Observations-Abiotic:	
Notes about tree:	This tree has a poor rooting environment and is in poor condition.
Tree Work-PHC:	
Tree Work-Other:	
Cycle:	
Last Modified:	02/09/2024
Management Notes:

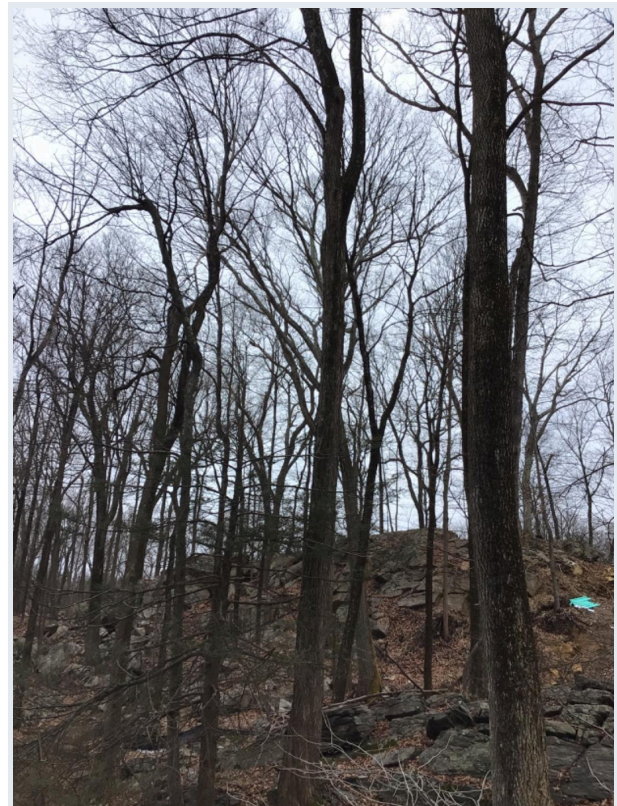
Northern red oak Tree ID #7

Tree Details	
Scientific Name:	Quercus rubra
Common Name:	Northern red oak
Genus:	Quercus
Condition:	40% - Poor
Status:	Alive
Number of Stems (Multi Calc):	1
DBH:	10
DBH Range:	6-12in
Height Range:	50ft-75ft
Risk Rating:	
Priority:	
Crown Spread:	
Canopy Shape:	Asymmetrical
Observations-Characteristics:	Deadwood, Soil Weakness
Observations-Biotic Pest:	
Observations-Abiotic:	
Notes about tree:	This tree has a poor crown, structure with deadwood throughout and a weak root zone.
Tree Work-PHC:	
Tree Work-Other:	
Cycle:	
Last Modified:	02/09/2024
Management Notes:

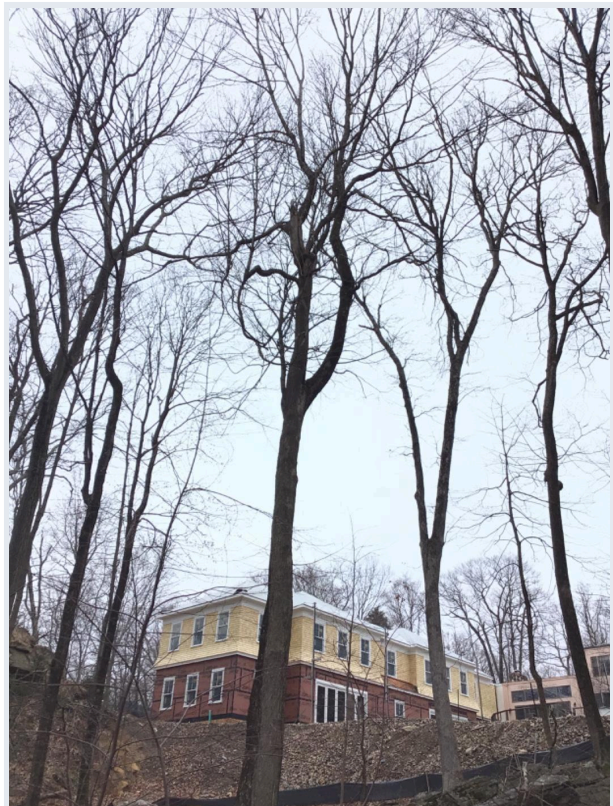
**Red maple Tree ID #8**

Tree Details	
Scientific Name:	Acer rubrum
Common Name:	Red maple
Genus:	Acer
Condition:	20% - Critical
Status:	Alive
Number of Stems (Multi Calc):	1
DBH:	16
DBH Range:	12-18in
Height Range:	50ft-75ft
Risk Rating:	
Priority:	
Crown Spread:	
Canopy Shape:	Asymmetrical
Observations-Characteristics:	Broken Limb, Deadwood, Crack, Soil Weakness
Observations-Biotic Pest:	
Observations-Abiotic:	
Notes about tree:	This tree has suffered a previous large limb failure and has a crack visible in the upper crown with large dead wood throughout.
Tree Work-PHC:	
Tree Work-Other:	
Cycle:	
Last Modified:	02/09/2024
Management Notes:

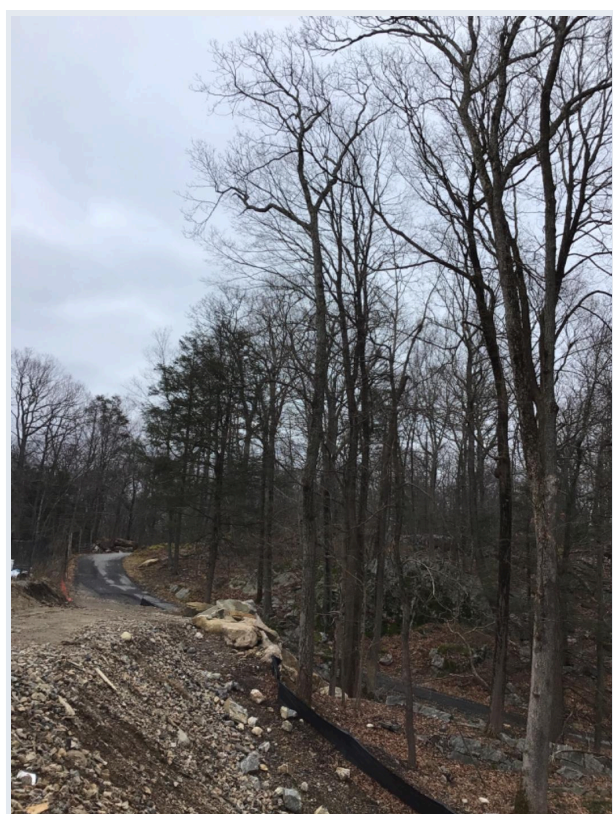
**Sassafras Tree ID #11**

Tree Details	
Scientific Name:	Sassafras albidum
Common Name:	Sassafras
Genus:	Sassafras
Condition:	40% - Poor
Status:	Alive
Number of Stems (Multi Calc):	1
DBH:	8
DBH Range:	6-12in
Height Range:	50ft-75ft
Risk Rating:	
Priority:	
Crown Spread:	
Canopy Shape:	Asymmetrical
Observations-Characteristics:	Deadwood, Soil Weakness
Observations-Biotic Pest:	
Observations-Abiotic:	Mechanical Damage
Notes about tree:	Damage along trunk exposing vascular tissue with a weak critical root zone.
Tree Work-PHC:	
Tree Work-Other:	
Cycle:	
Last Modified:	02/09/2024
Management Notes:

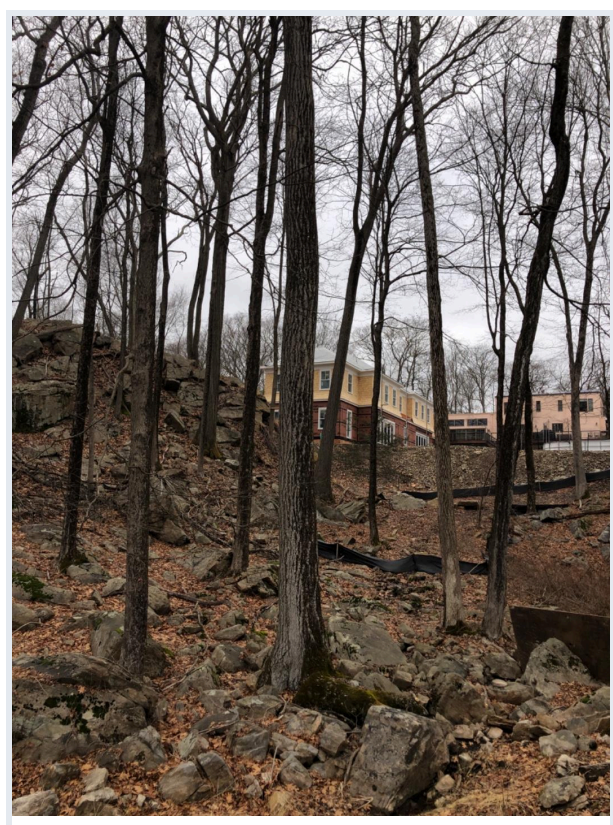
**Northern red oak Tree ID #12**

Tree Details	
Scientific Name:	Quercus rubra
Common Name:	Northern red oak
Genus:	Quercus
Condition:	60% - Fair
Status:	Alive
Number of Stems (Multi Calc):	1
DBH:	10
DBH Range:	6-12in
Height Range:	30ft-50ft
Risk Rating:	
Priority:	
Crown Spread:	
Canopy Shape:	Symmetrical
Observations-Characteristics:	Soil Weakness
Observations-Biotic Pest:	
Observations-Abiotic:	
Notes about tree:	This tree has a poor rooting environment.
Tree Work-PHC:	
Tree Work-Other:	
Cycle:	
Last Modified:	02/09/2024
Management Notes:

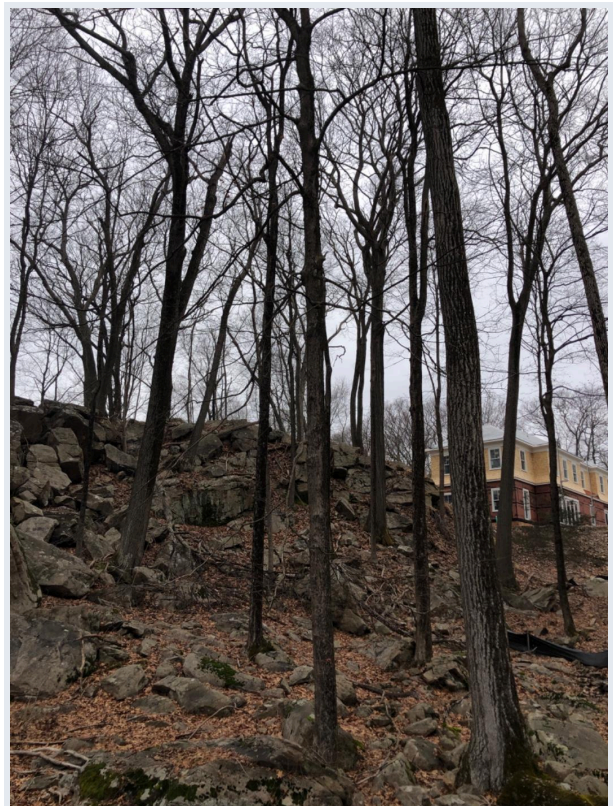
**Red maple Tree ID #13**

Tree Details	
Scientific Name:	Acer rubrum
Common Name:	Red maple
Genus:	Acer
Condition:	40% - Poor
Status:	Alive
Number of Stems (Multi Calc):	1
DBH:	10
DBH Range:	6-12in
Height Range:	50ft-75ft
Risk Rating:	
Priority:	
Crown Spread:	
Canopy Shape:	Asymmetrical
Observations-Characteristics:	Deadwood, Broken Limb, Soil Weakness
Observations-Biotic Pest:	
Observations-Abiotic:	
Notes about tree:	This tree has deadwood throughout the crown.
Tree Work-PHC:	
Tree Work-Other:	
Cycle:	
Last Modified:	02/09/2024
Management Notes:

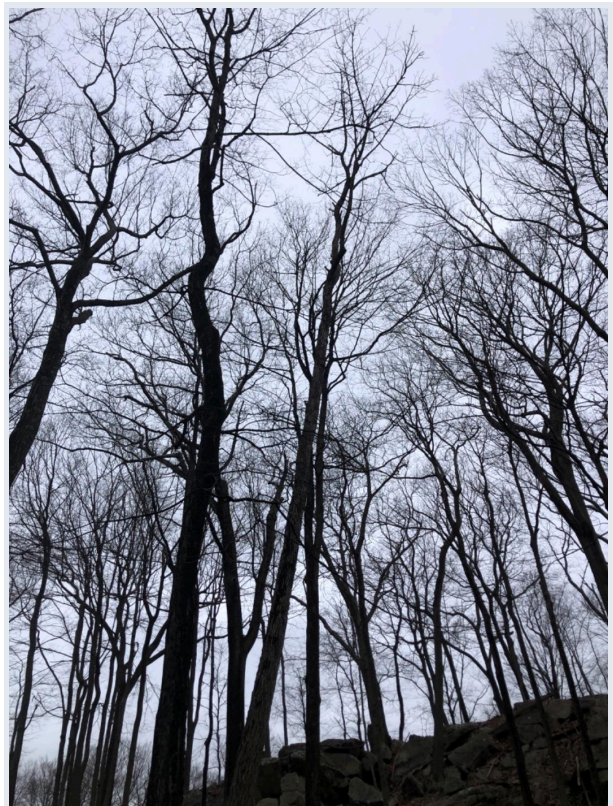
Ash Tree ID #14

Scientific Name:	Fraxinus species
Common Name:	Ash
Genus:	Fraxinus
Condition:	20% - Critical
Status:	Alive
Number of Stems (Multi Calc):	1
DBH:	14
DBH Range:	12-18in
Height Range:	50ft-75ft
Risk Rating:	
Priority:	
Crown Spread:	
Canopy Shape:	Asymmetrical
Observations-Characteristics:	Broken Limb, Deadwood
Observations-Biotic Pest:	Boring Insect
Observations-Abiotic:	
Notes about tree:	This tree has a visible damage from Emerald Ash Borer, it is no longer viable.
Tree Work-PHC:	
Tree Work-Other:	
Cycle:	
Last Modified:	02/09/2024
Management Notes:

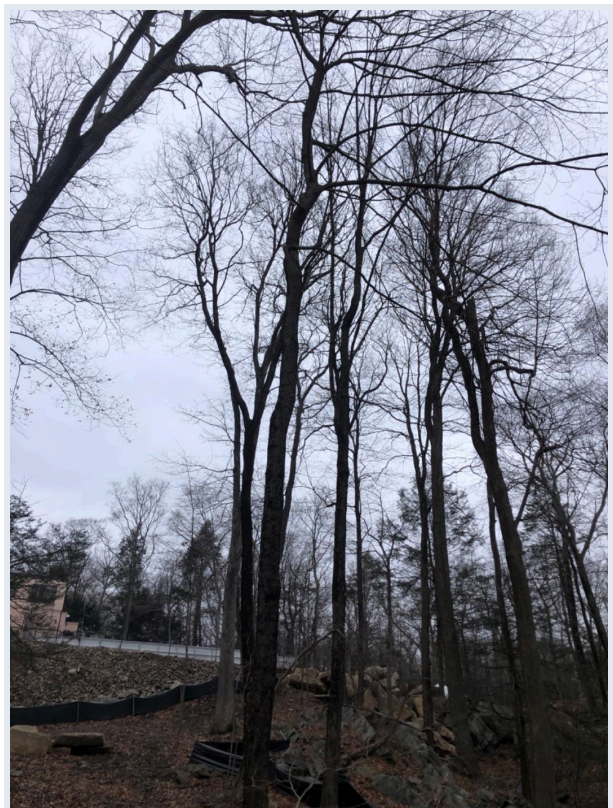
**Red maple Tree ID #15**

Scientific Name:	Acer rubrum
Common Name:	Red maple
Genus:	Acer
Condition:	40% - Poor
Status:	Alive
Number of Stems (Multi Calc):	1
DBH:	10
DBH Range:	6-12in
Height Range:	50ft-75ft
Risk Rating:	
Priority:	
Crown Spread:	
Canopy Shape:	Asymmetrical
Observations-Characteristics:	Soil Weakness
Observations-Biotic Pest:	
Observations-Abiotic:	
Notes about tree:	This tree has a weak critical root zone.
Tree Work-PHC:	
Tree Work-Other:	
Cycle:	
Last Modified:	02/09/2024
Management Notes:

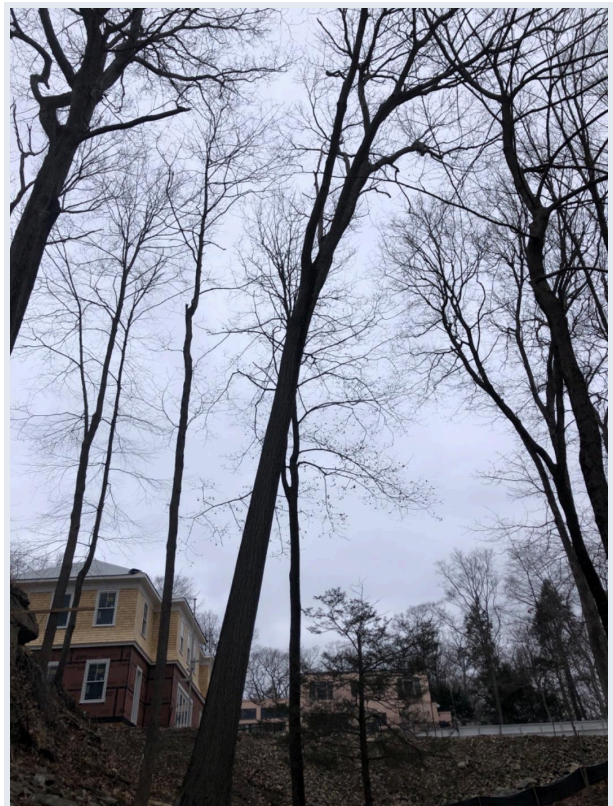
**Northern red oak Tree ID #16**

Tree Details	
Scientific Name:	Quercus rubra
Common Name:	Northern red oak
Genus:	Quercus
Condition:	40% - Poor
Status:	Alive
Number of Stems (Multi Calc):	1
DBH:	22
DBH Range:	18-24in
Height Range:	50ft-75ft
Risk Rating:	
Priority:	
Crown Spread:	
Canopy Shape:	Asymmetrical
Observations-Characteristics:	Soil Weakness, Broken Limb, Deadwood, Leaning trunk
Observations-Biotic Pest:	
Observations-Abiotic:	
Notes about tree:	This tree has a large lean, extending out towards the new road and proposed pool. There is large deadwood and snapped limbs in the crown.
Tree Work-PHC:	
Tree Work-Other:	
Cycle:	
Last Modified:	02/09/2024
Management Notes:

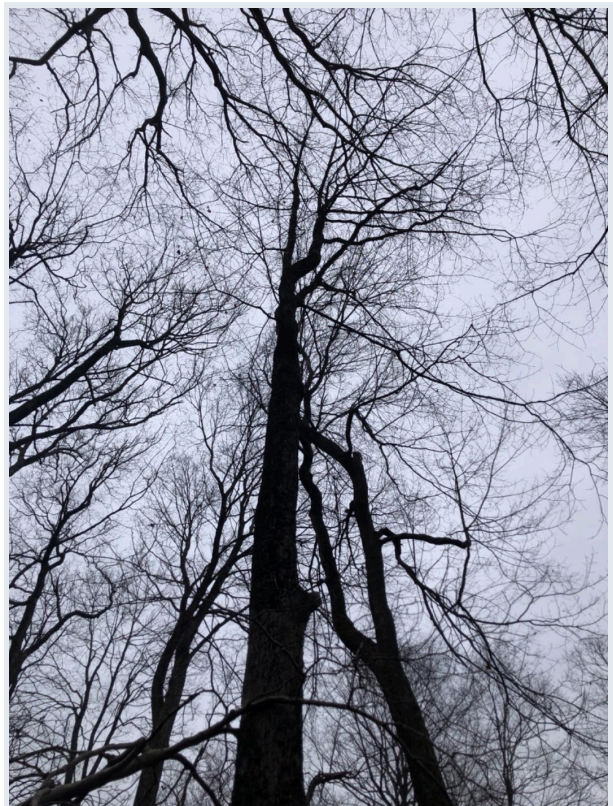
**Red maple Tree ID #17**

Scientific Name:	Acer rubrum
Common Name:	Red maple
Genus:	Acer
Condition:	60% - Fair
Status:	Alive
Number of Stems (Multi Calc):	1
DBH:	17
DBH Range:	12-18in
Height Range:	50ft-75ft
Risk Rating:	
Priority:	
Crown Spread:	
Canopy Shape:	Asymmetrical
Observations-Characteristics:	Soil Weakness, Deadwood
Observations-Biotic Pest:	
Observations-Abiotic:	
Notes about tree:	This tree has dead and broken limbs in the crown.
Tree Work-PHC:	
Tree Work-Other:	
Cycle:	
Last Modified:	02/09/2024
Management Notes:

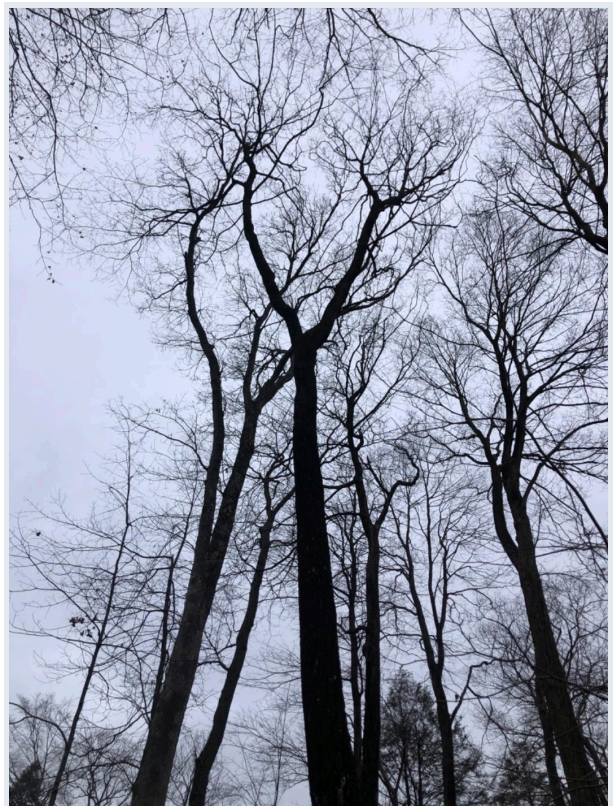
**Red maple Tree ID #18**

Tree Details	
Scientific Name:	Acer rubrum
Common Name:	Red maple
Genus:	Acer
Condition:	60% - Fair
Status:	Alive
Number of Stems (Multi Calc):	1
DBH:	14
DBH Range:	12-18in
Height Range:	50ft-75ft
Risk Rating:	
Priority:	
Crown Spread:	
Canopy Shape:	Asymmetrical
Observations-Characteristics:	Soil Weakness
Observations-Biotic Pest:	
Observations-Abiotic:	
Notes about tree:	The upper crown of this tree has a bifurcation increasing the likelihood of storm damage. It also has a weak root zone.
Tree Work-PHC:	
Tree Work-Other:	
Cycle:	
Last Modified:	02/09/2024
Management Notes:

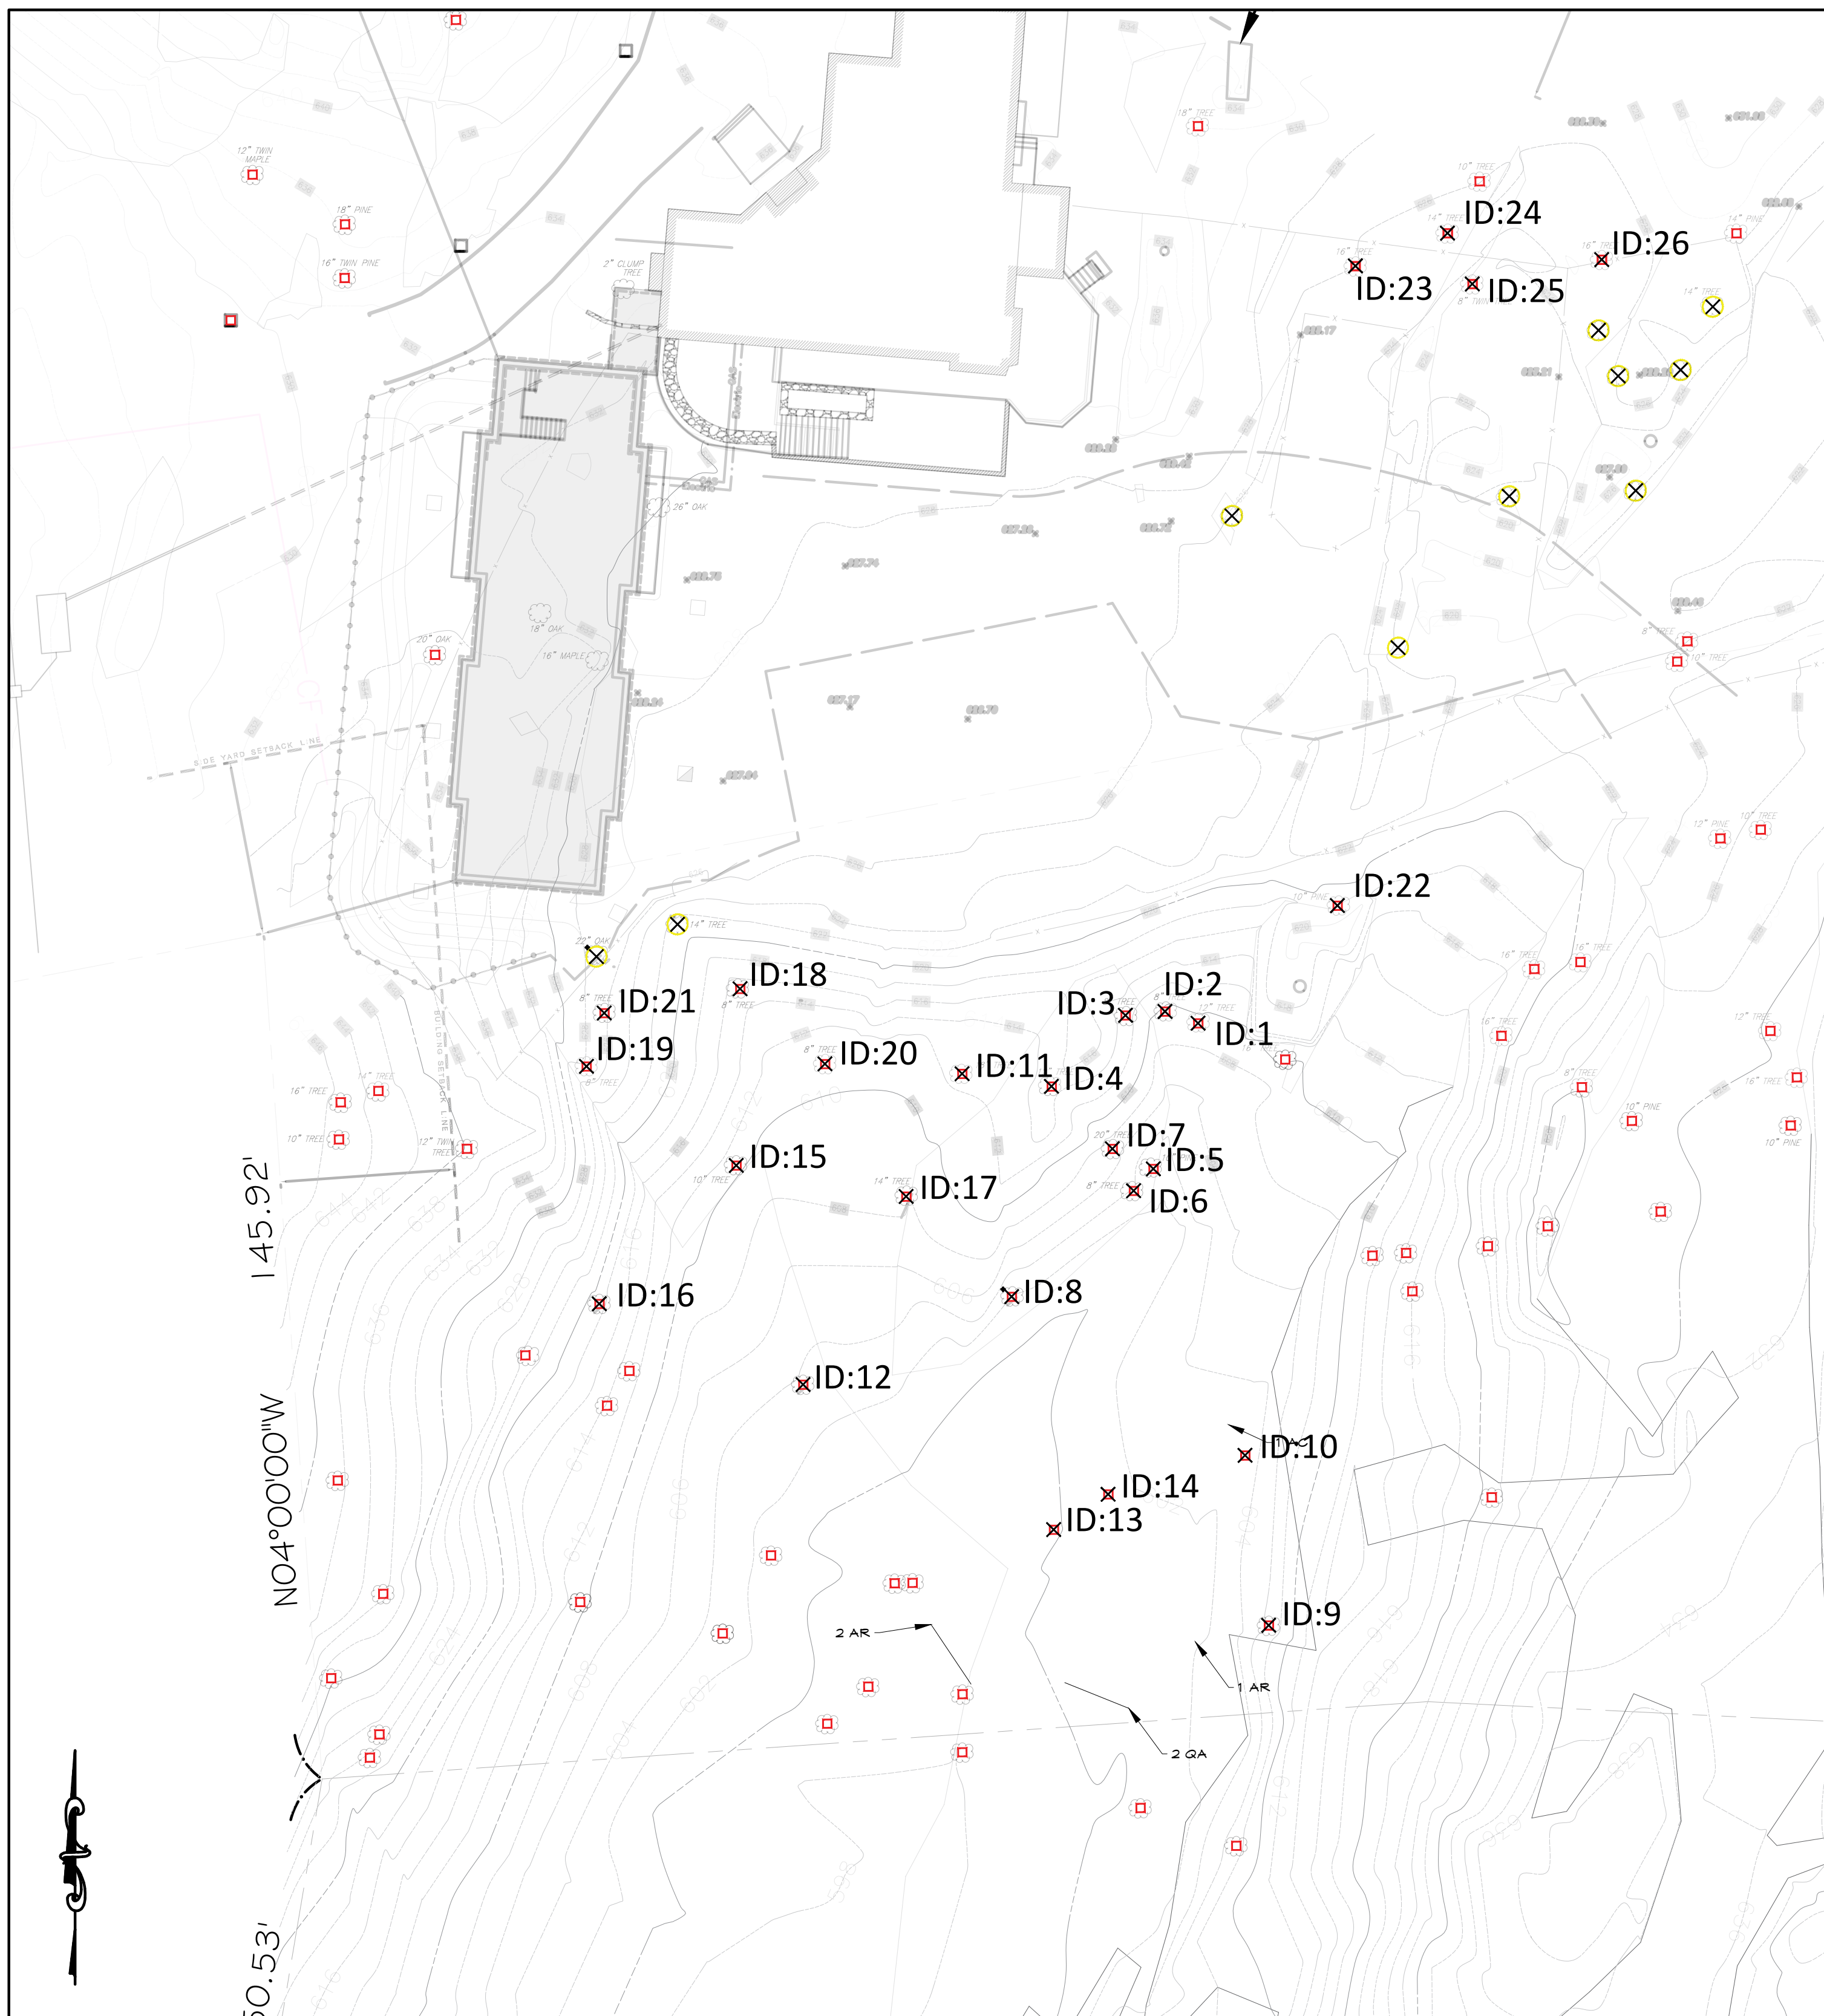
Drawing Title  
**Tree Removals**

#	SIZE	TREE	CONDITION
ID:1	13 IN	ASH	CRITICAL
ID:2	10 IN	HICKORY	FAIR
ID:3	9 IN	HICKORY	POOR
ID:4	12 IN	HICKORY	POOR
ID:5	10 IN	HEMLOCK	POOR
ID:6	8 IN	BLACK BIRCH	POOR
ID:7	10 IN	RED OAK	POOR
ID:8	16 IN	RED MAPLE	CRITICAL
ID:9	9 IN	RED MAPLE	POOR
ID:10	15 IN	RED MAPLE	POOR
ID:11	8 IN	SASSAFRASS	POOR
ID:12	10 IN	RED OAK	FAIR
ID:13	10 IN	RED MAPLE	POOR
ID:14	14 IN	ASH	CRITICAL
ID:15	10 IN	RED MAPLE	POOR
ID:16	22 IN	RED OAK	POOR
ID:17	17 IN	RED MAPLE	FAIR
ID:18	14 IN	RED MAPLE	FAIR
ID:19	20 IN	WHITE OAK	POOR
ID:20	11 IN	RED MAPLE	CRITICAL
ID:21	10 IN	RED MAPLE	POOR
ID:22	10 IN	HEMLOCK	POOR
ID:23	16 IN	BEECH	FAIR
ID:24	14 IN	CHESTNUT OAK	POOR
ID:25	8 IN TWIN	OAK	POOR
ID:26	16 IN	TULIP	FAIR
