JAY FAIN & ASSOCIATES, LLC

Re: Special Use Permit/Site Plan Application, Additional Horses, 263 Bedford Banksville Road

On behalf of Kent Farrington LLC, we are pleased to submit a Special Use Permit Application/Site Plan Application for additional horses for property situated at 263 Bedford Banksville Road. In support of these Applications, we have attached the following supporting documents:

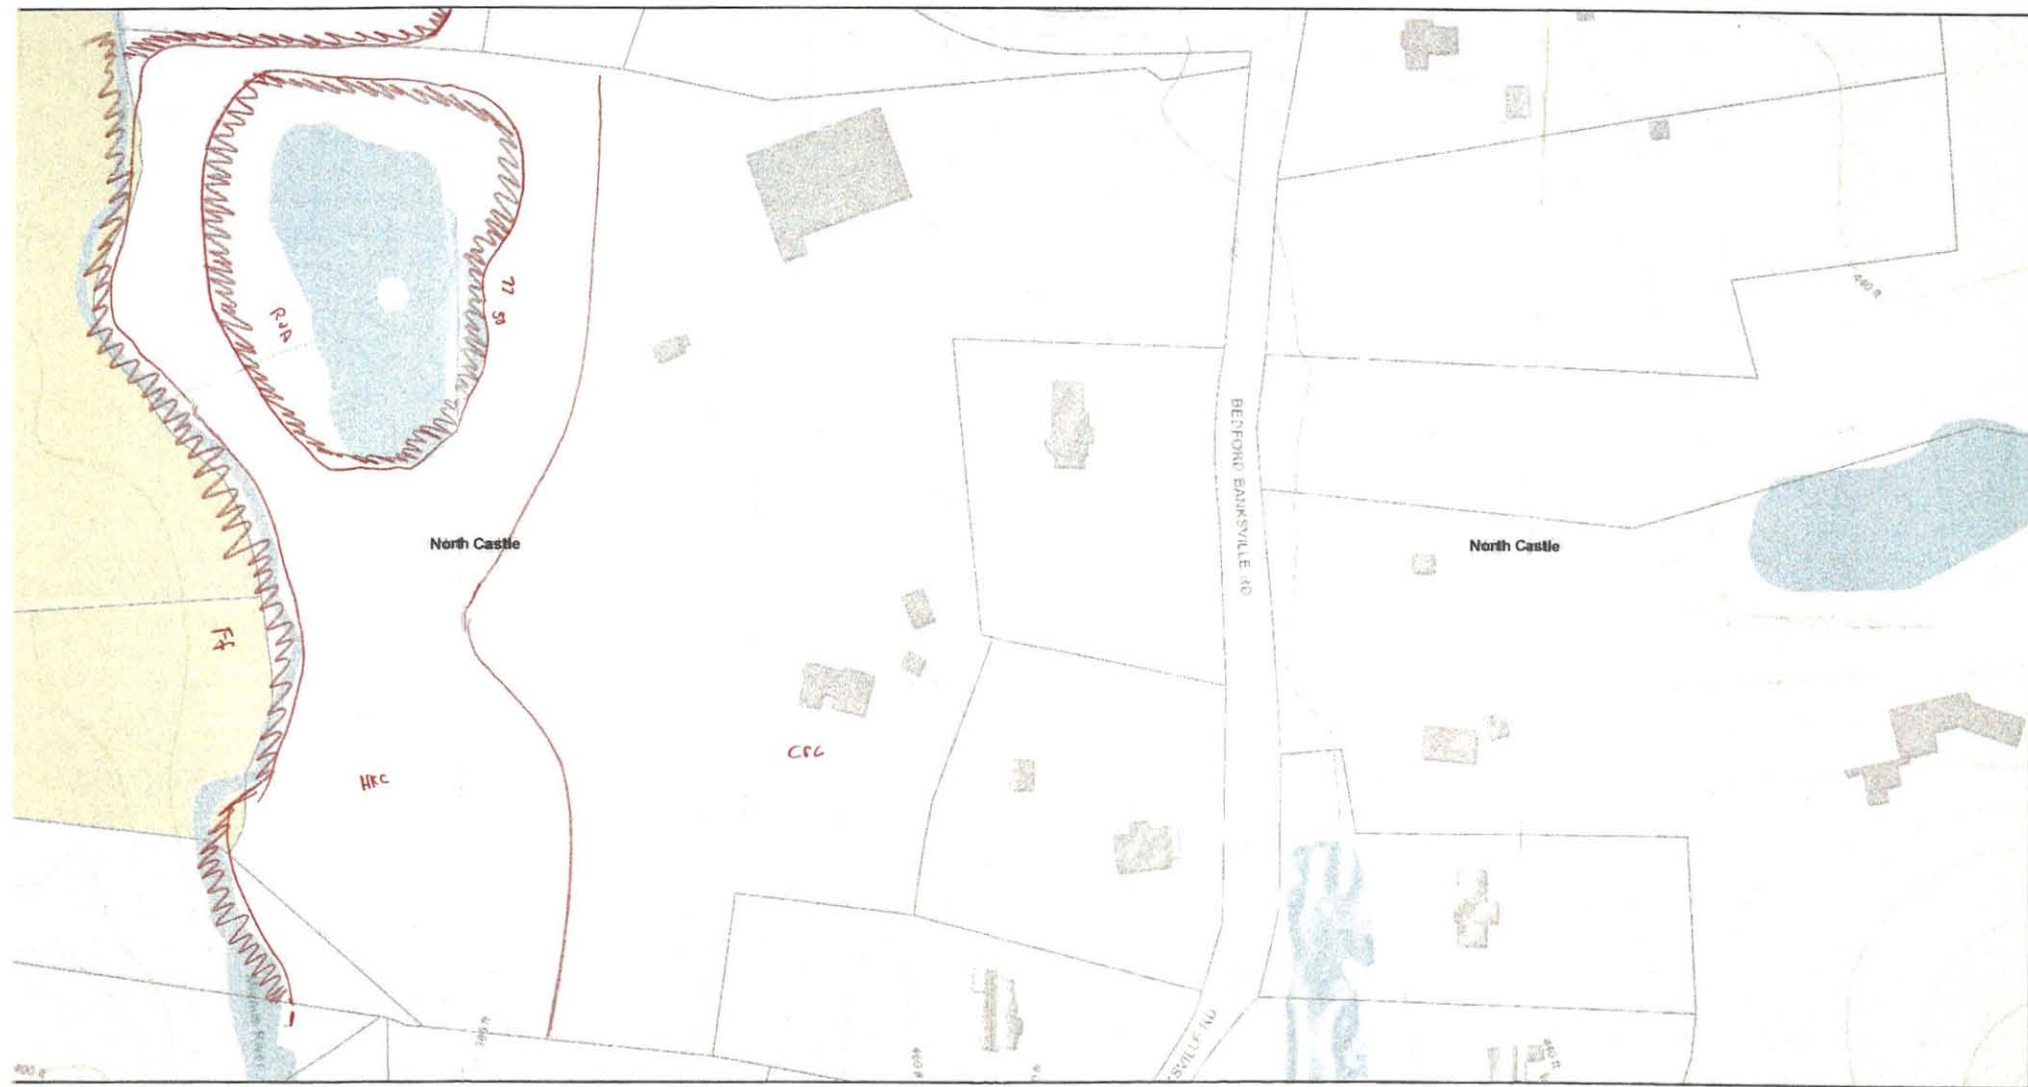
1-33 river
50-77 pond/out

Wetland Sketch Map
JFA - 12/2/20
1-33 - Flood plain
50-77 - Pond

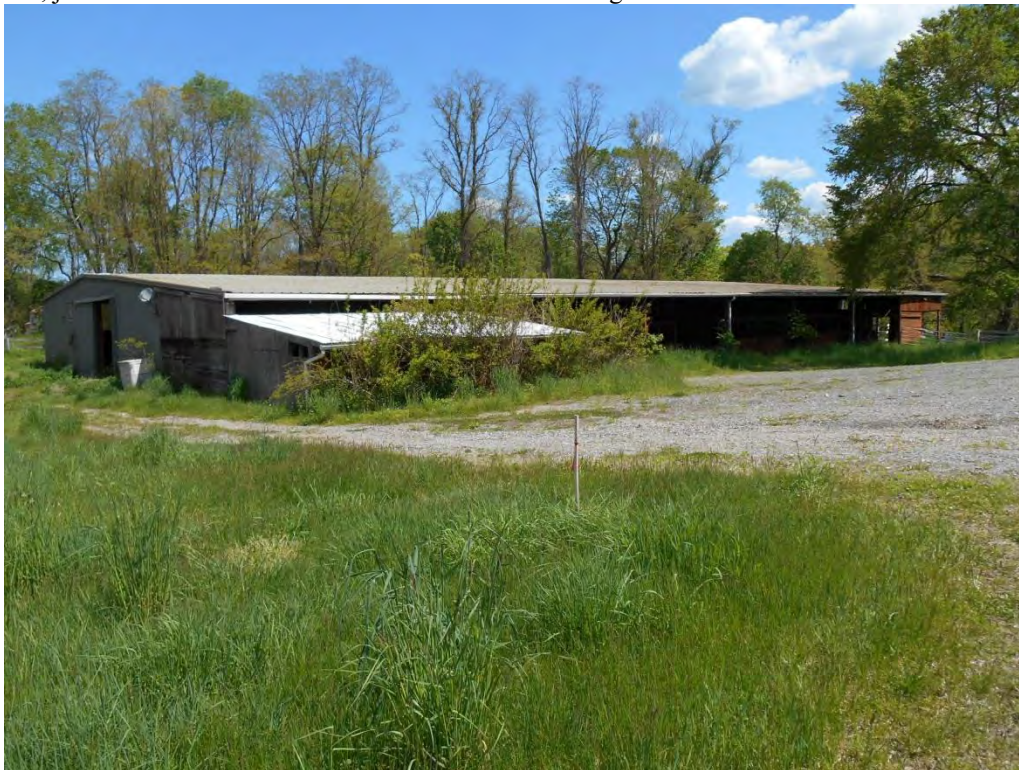
Photograph 4. The indoor riding arena. The shed addition at the front of the building is proposed to be demolished. View looking northeast.

- Photograph 4. The indoor riding arena. The shed addition at the front of the building is proposed to be demolished. View looking northeast.
- Photograph 5. The interior of the indoor riding arena. View looking southwest.

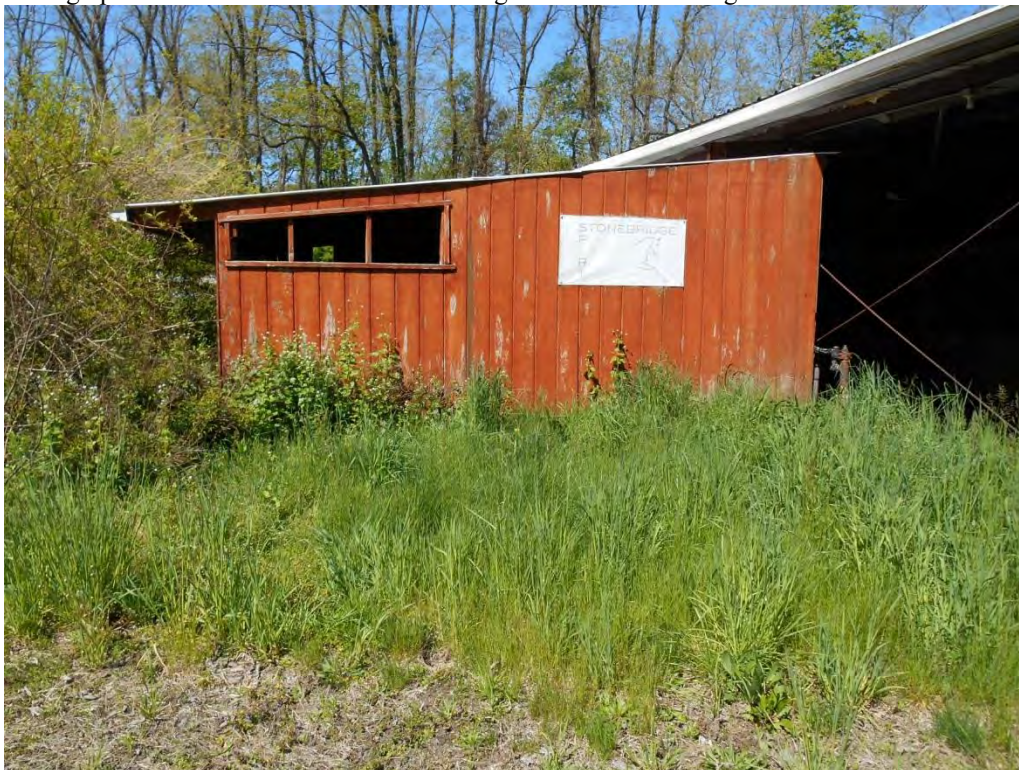
Photograph 6. Detail of the shed addition to the indoor riding arena that is proposed to be demolished. View looking southwest.

- Photograph 6. Detail of the shed addition to the indoor riding arena that is proposed to be demolished. View looking southwest.
- Photograph 7. The indoor riding arena on the right, with the area proposed for new medical paddocks in the left background, where there are soil mounds and trees. View looking northwest.

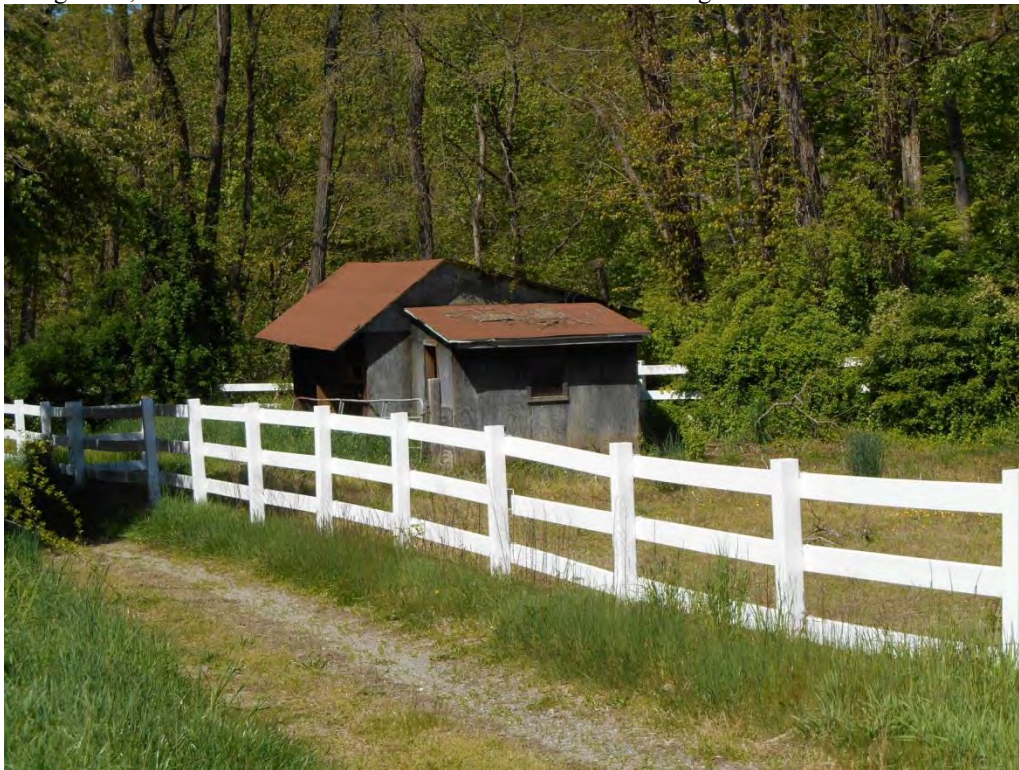
Photograph 8. An existing paddock with a one-story horse stall and shed, which is proposed to be demolished. View looking southwest.

- Photograph 8. An existing paddock with a one-story horse stall and shed, which is proposed to be demolished. View looking southwest.
- Photograph 9. Detail of the one-story frame horse stall and shed that is proposed to be demolished. View looking north.

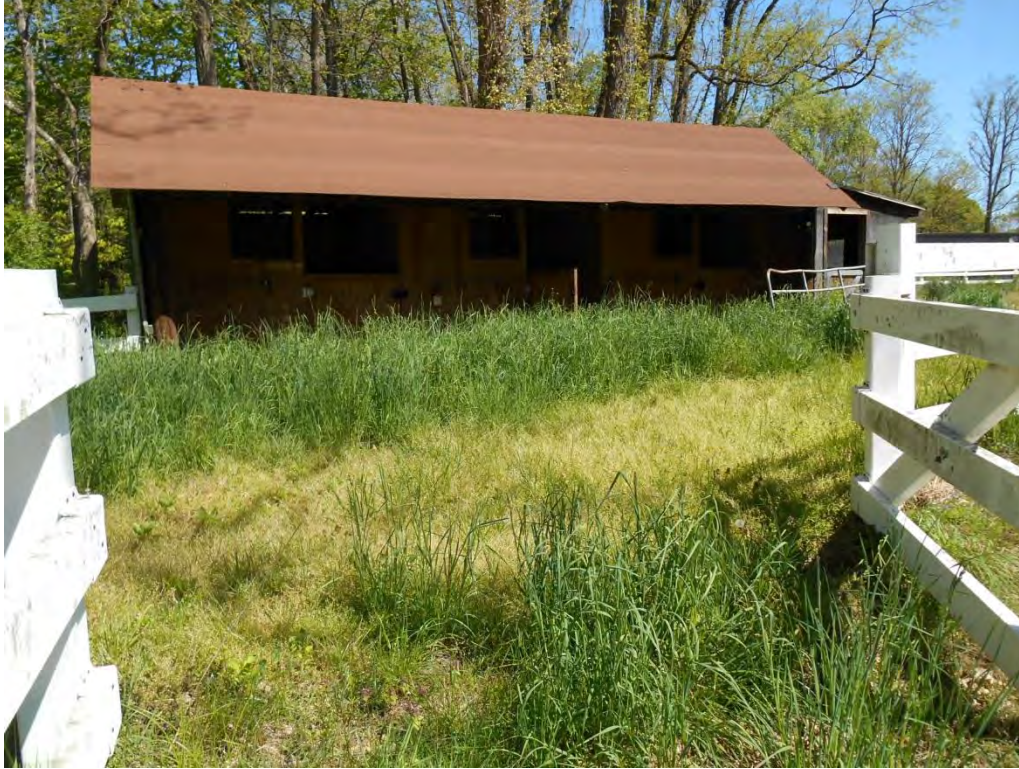
Photograph 9. Detail of the one-story frame horse stall and shed that is proposed to be demolished. View looking north.

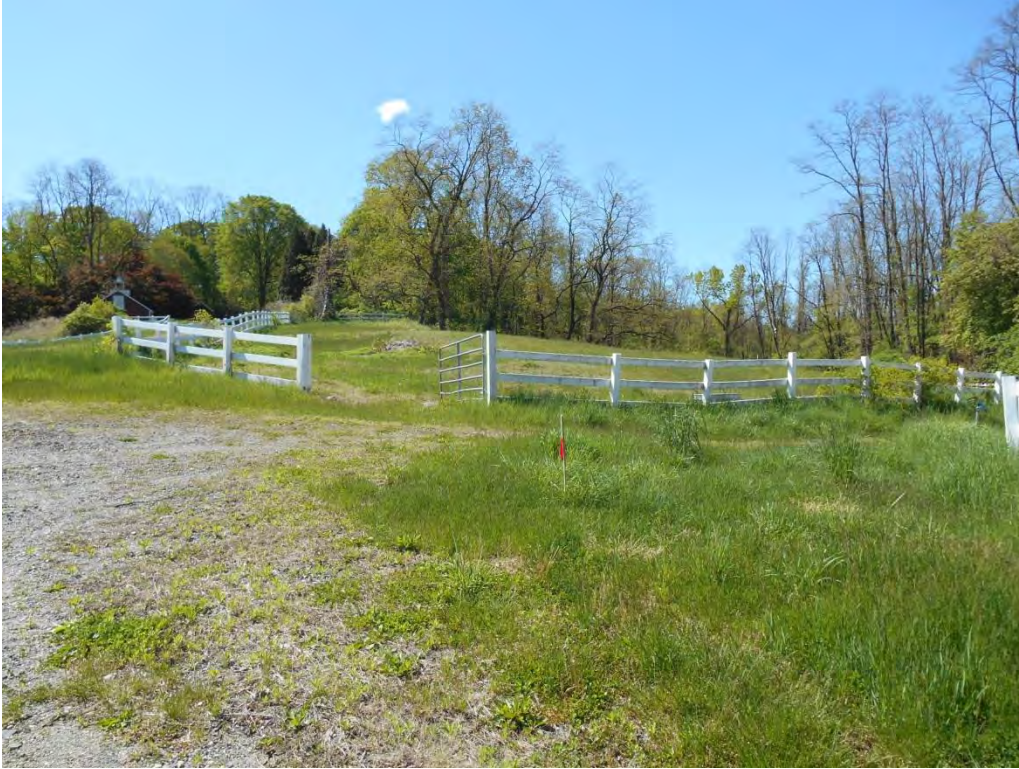
Photograph 11. The existing paddock on the west side of the gravel driveway leading to the residence. The portion of the paddock on the right will be taken to build the proposed new stable. View looking southwest.

- Photograph 10. The existing paddocks on the east side of the gravel driveway leading to the residence. View looking south.
- Photograph 11. The existing paddock on the west side of the gravel driveway leading to the residence. The portion of the paddock on the right will be taken to build the proposed new stable. View looking southwest.

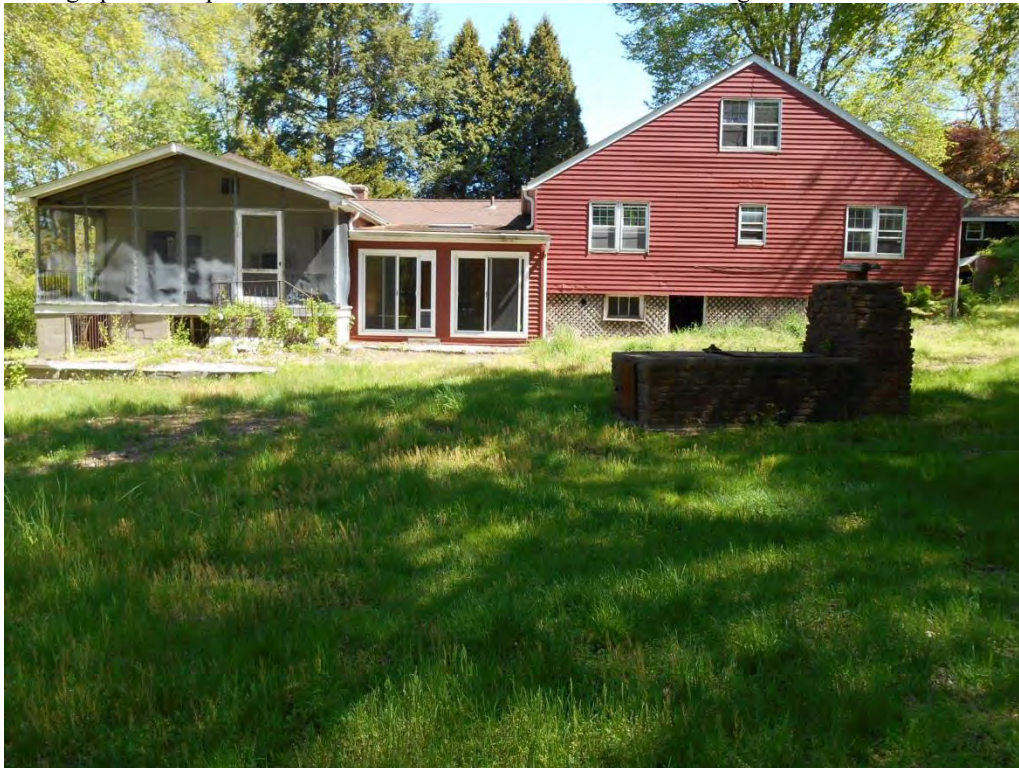
Photograph 14. The rear of the residence and the back yard, with the brick barbeque. An underground storage tank was removed from an area near the screened porch on the left. View looking northeast.

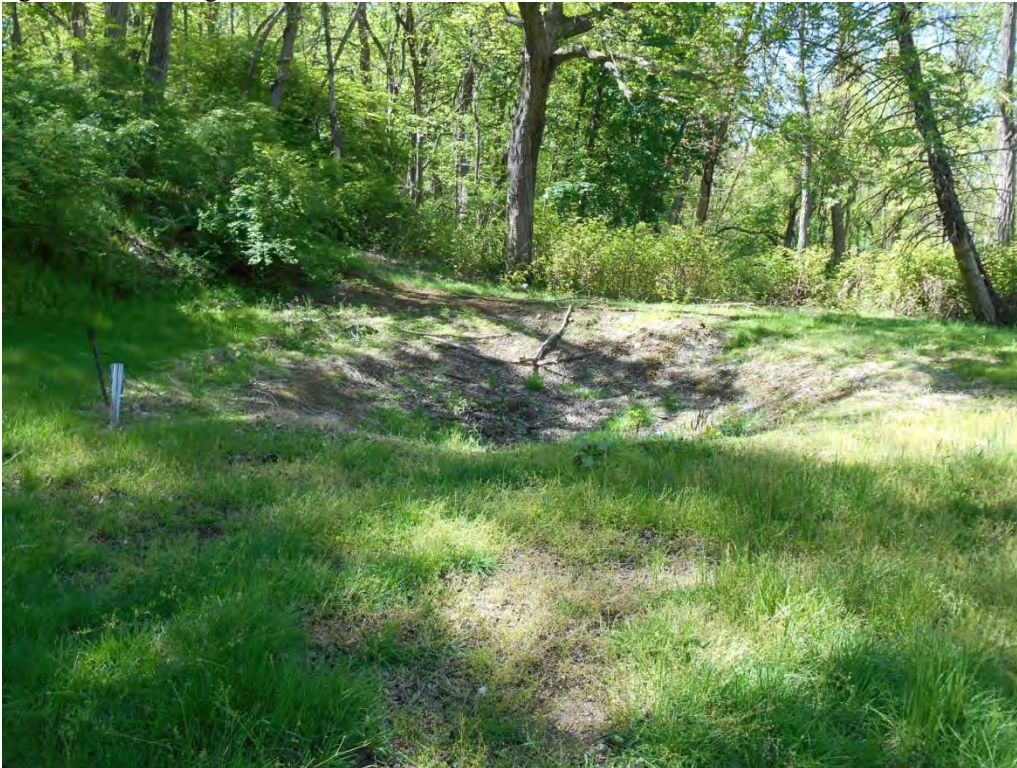
Photograph 16. The rear yard of the residence showing a large pit where a former water tank/tower was located. View looking south.

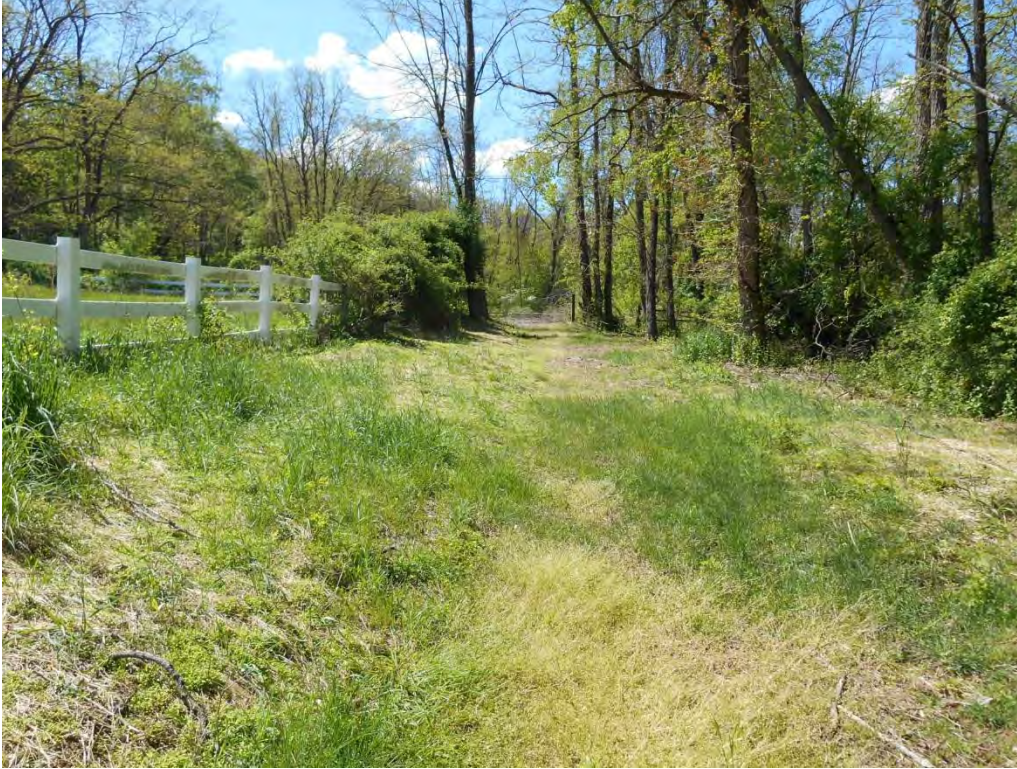
Photograph 19. The location where the new stable is proposed, overlapping the enclosed paddock on the left. View looking south.

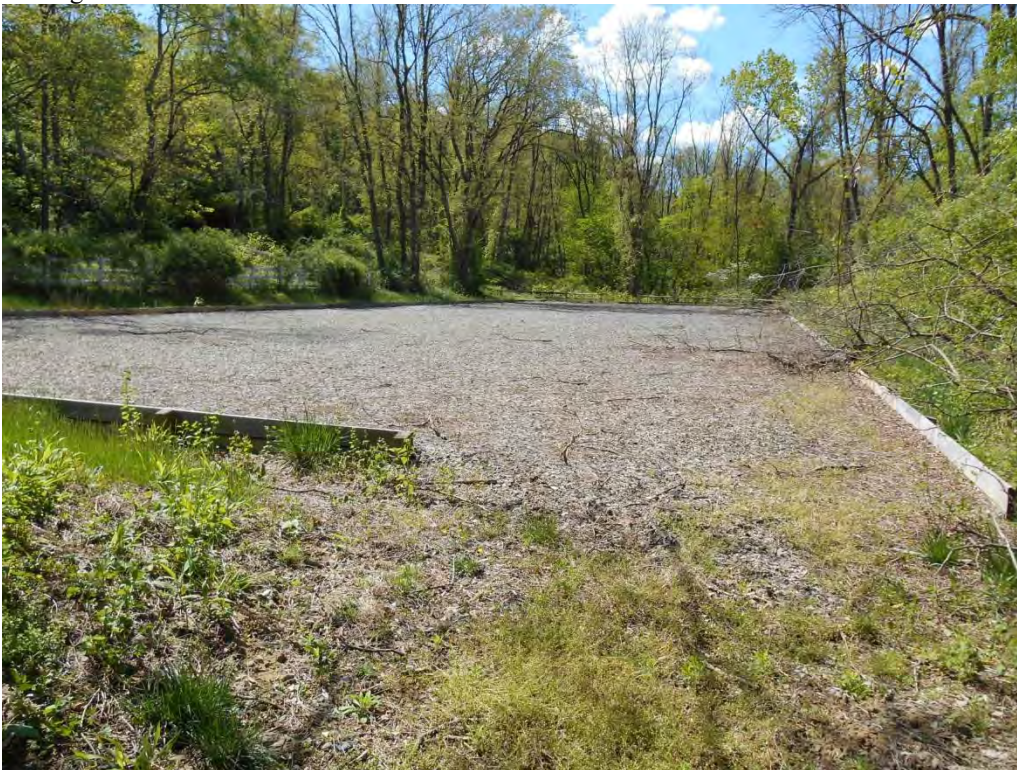
Photograph 20. The existing outdoor riding arena, which is proposed to be enlarged on the left and the right. View looking south.

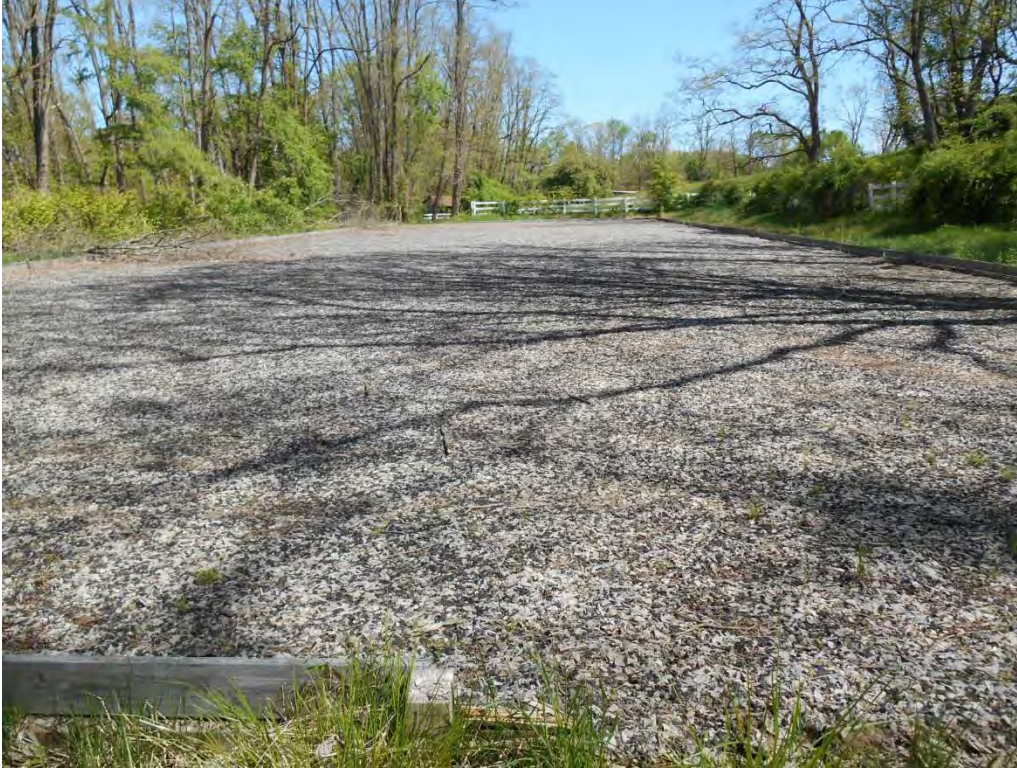
Photograph 21. The existing outdoor riding arena, which is proposed to be enlarged on the left and the right. View looking north.

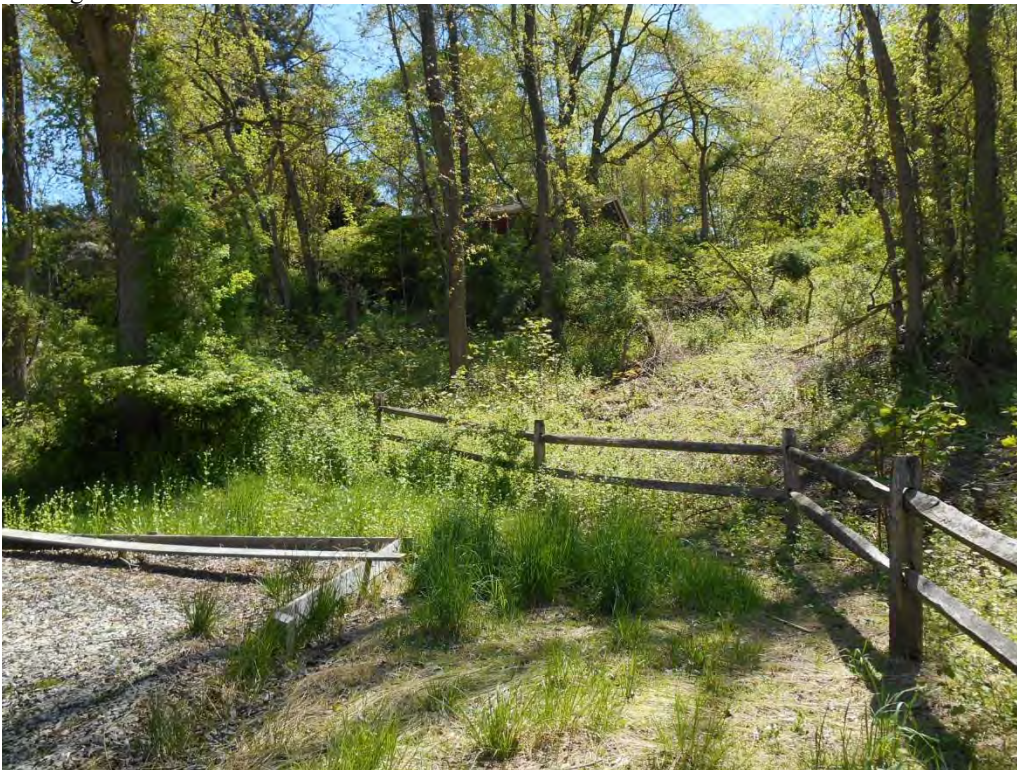
Photograph 22. The hillside between the outdoor riding arena on the left and the residence in the background. A portion of this hillside will be graded to enlarge the arena. View looking east.

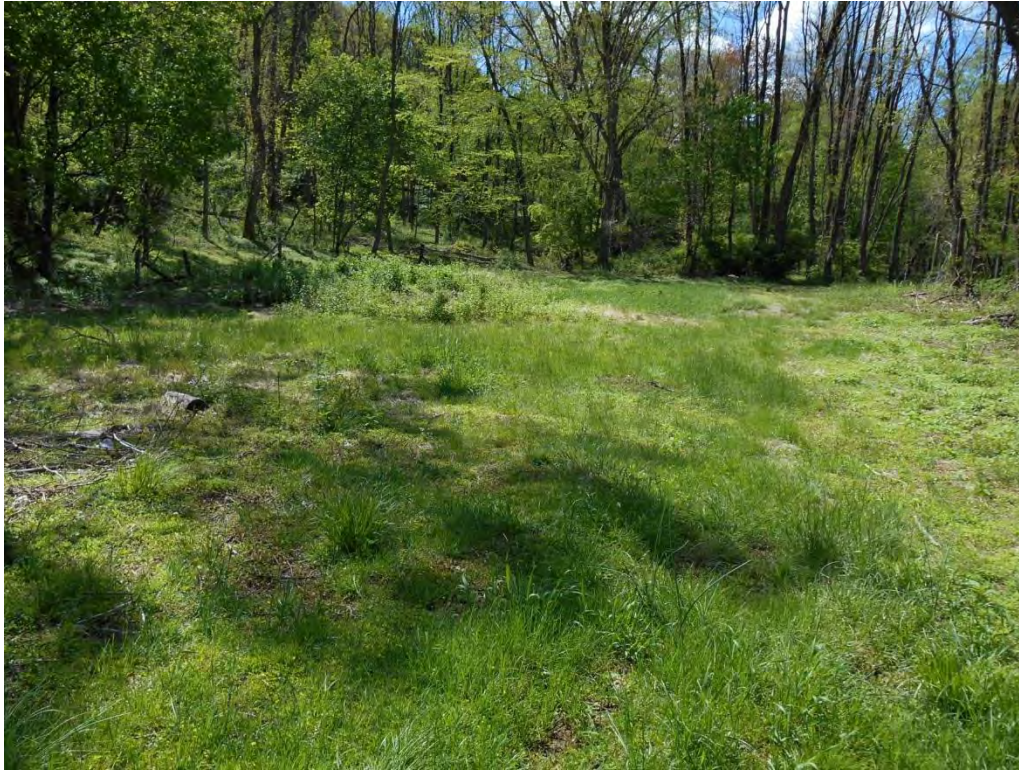
Photograph 23. The location proposed for a new outdoor riding arena, including both the open area and the wooded area in the background. View looking south.

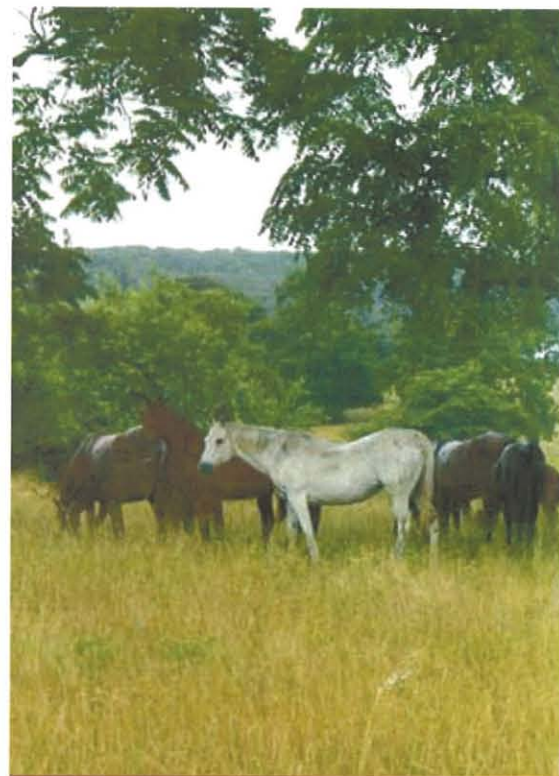
Rotational-grazing paddock layout example

For example, if you have two horses and four acres of pasture, you could divide the pasture into eight, one-half-acre paddocks. In the spring, when the grass is growing rapidly, grazing each paddock for three days will give each paddock 21 days to recover before they are grazed again. In a dry summer month, the recovery period could be 60 days, so the grazing period on each paddock would have to be extended to eight to nine days to accommodate this.

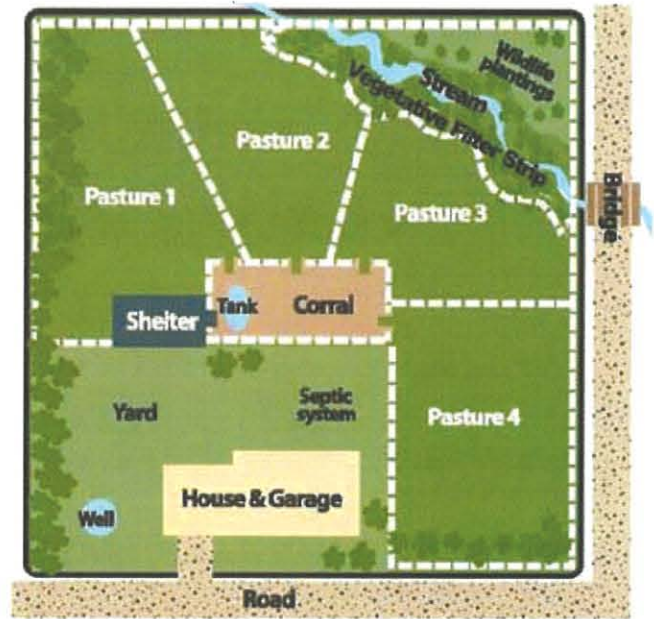
Example of small-acreage grazing system with lot and stalls

For example, if you only have enough land to grow forage for three horses, and you have four horses, they will have to be kept in a corral or stalls and fed hay during times when the grass grows slowly to make it possible to give the forages the proper amount of rest before they are regrazed.

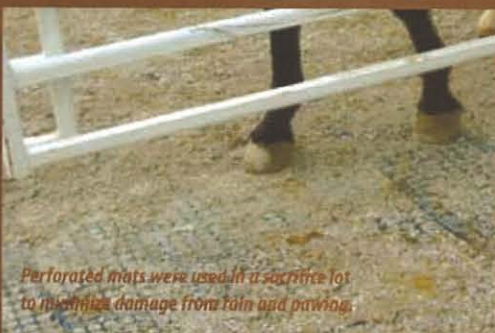
Perforated mats were used in a sacrifice lot to minimize damage from rain and pawing.

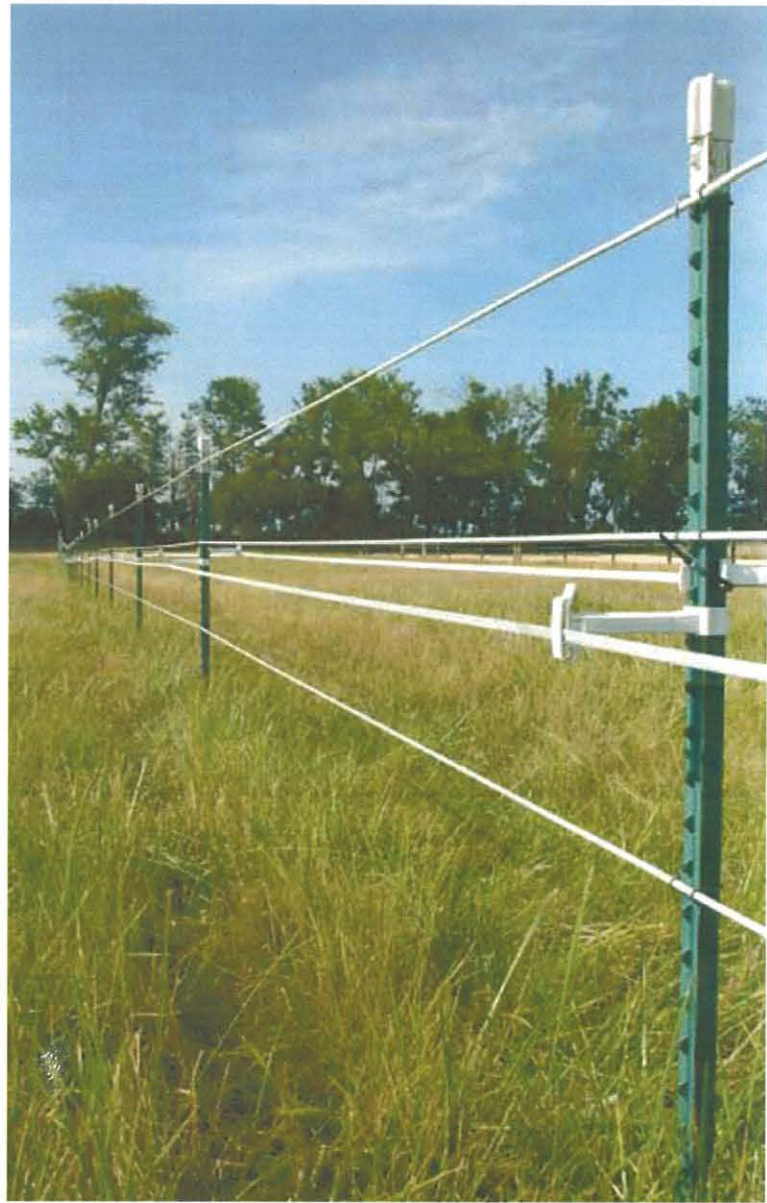
Plastic-coated horsewire, an example of permanent fencing wire, is more visible and less likely to cut a horse that may run into it.

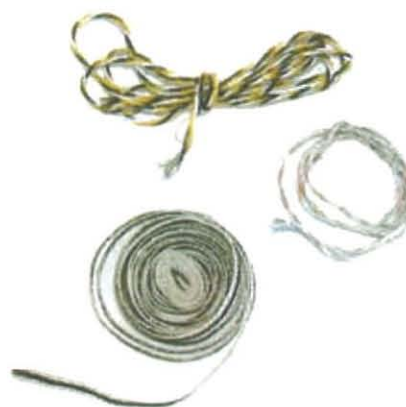
Examples of temporary fencing wire.

strung on lightweight plastic or fiberglass posts works well for dividing a pasture into paddocks in a rotational-grazing system. Use of small, uncoated, 14-gauge or 18-gauge wire commonly used with cattle is not recommended because it is not safe for horses, primarily because they cannot see it. Because of their poor eyesight, horses often make contact with the electric fence, which shocks them and makes them run. This can be disastrous if the wire gets wrapped around a horse's leg. The small wire can also cut horses when they run into it.

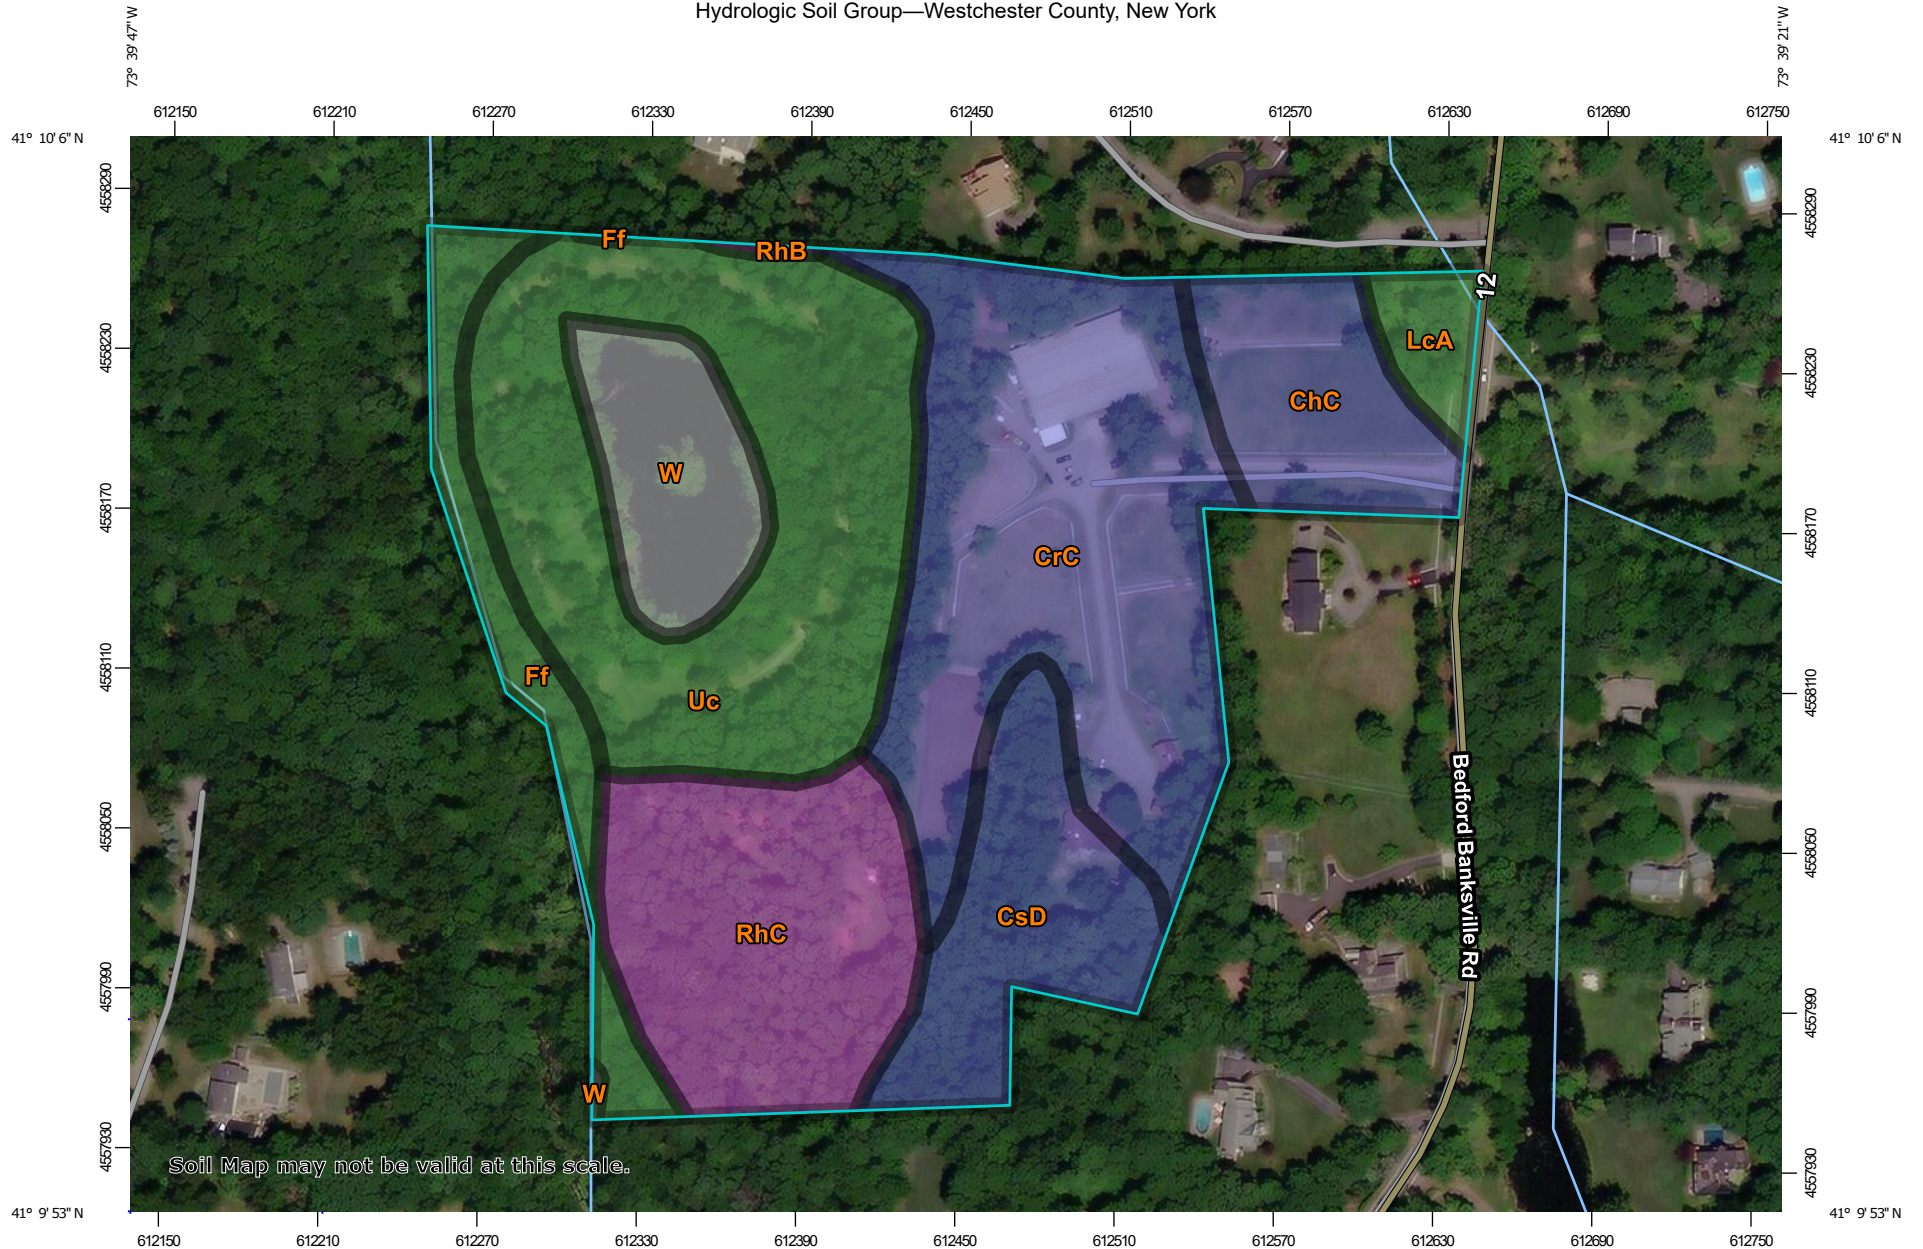
Hydrologic Soil Group—Westchester County, New York

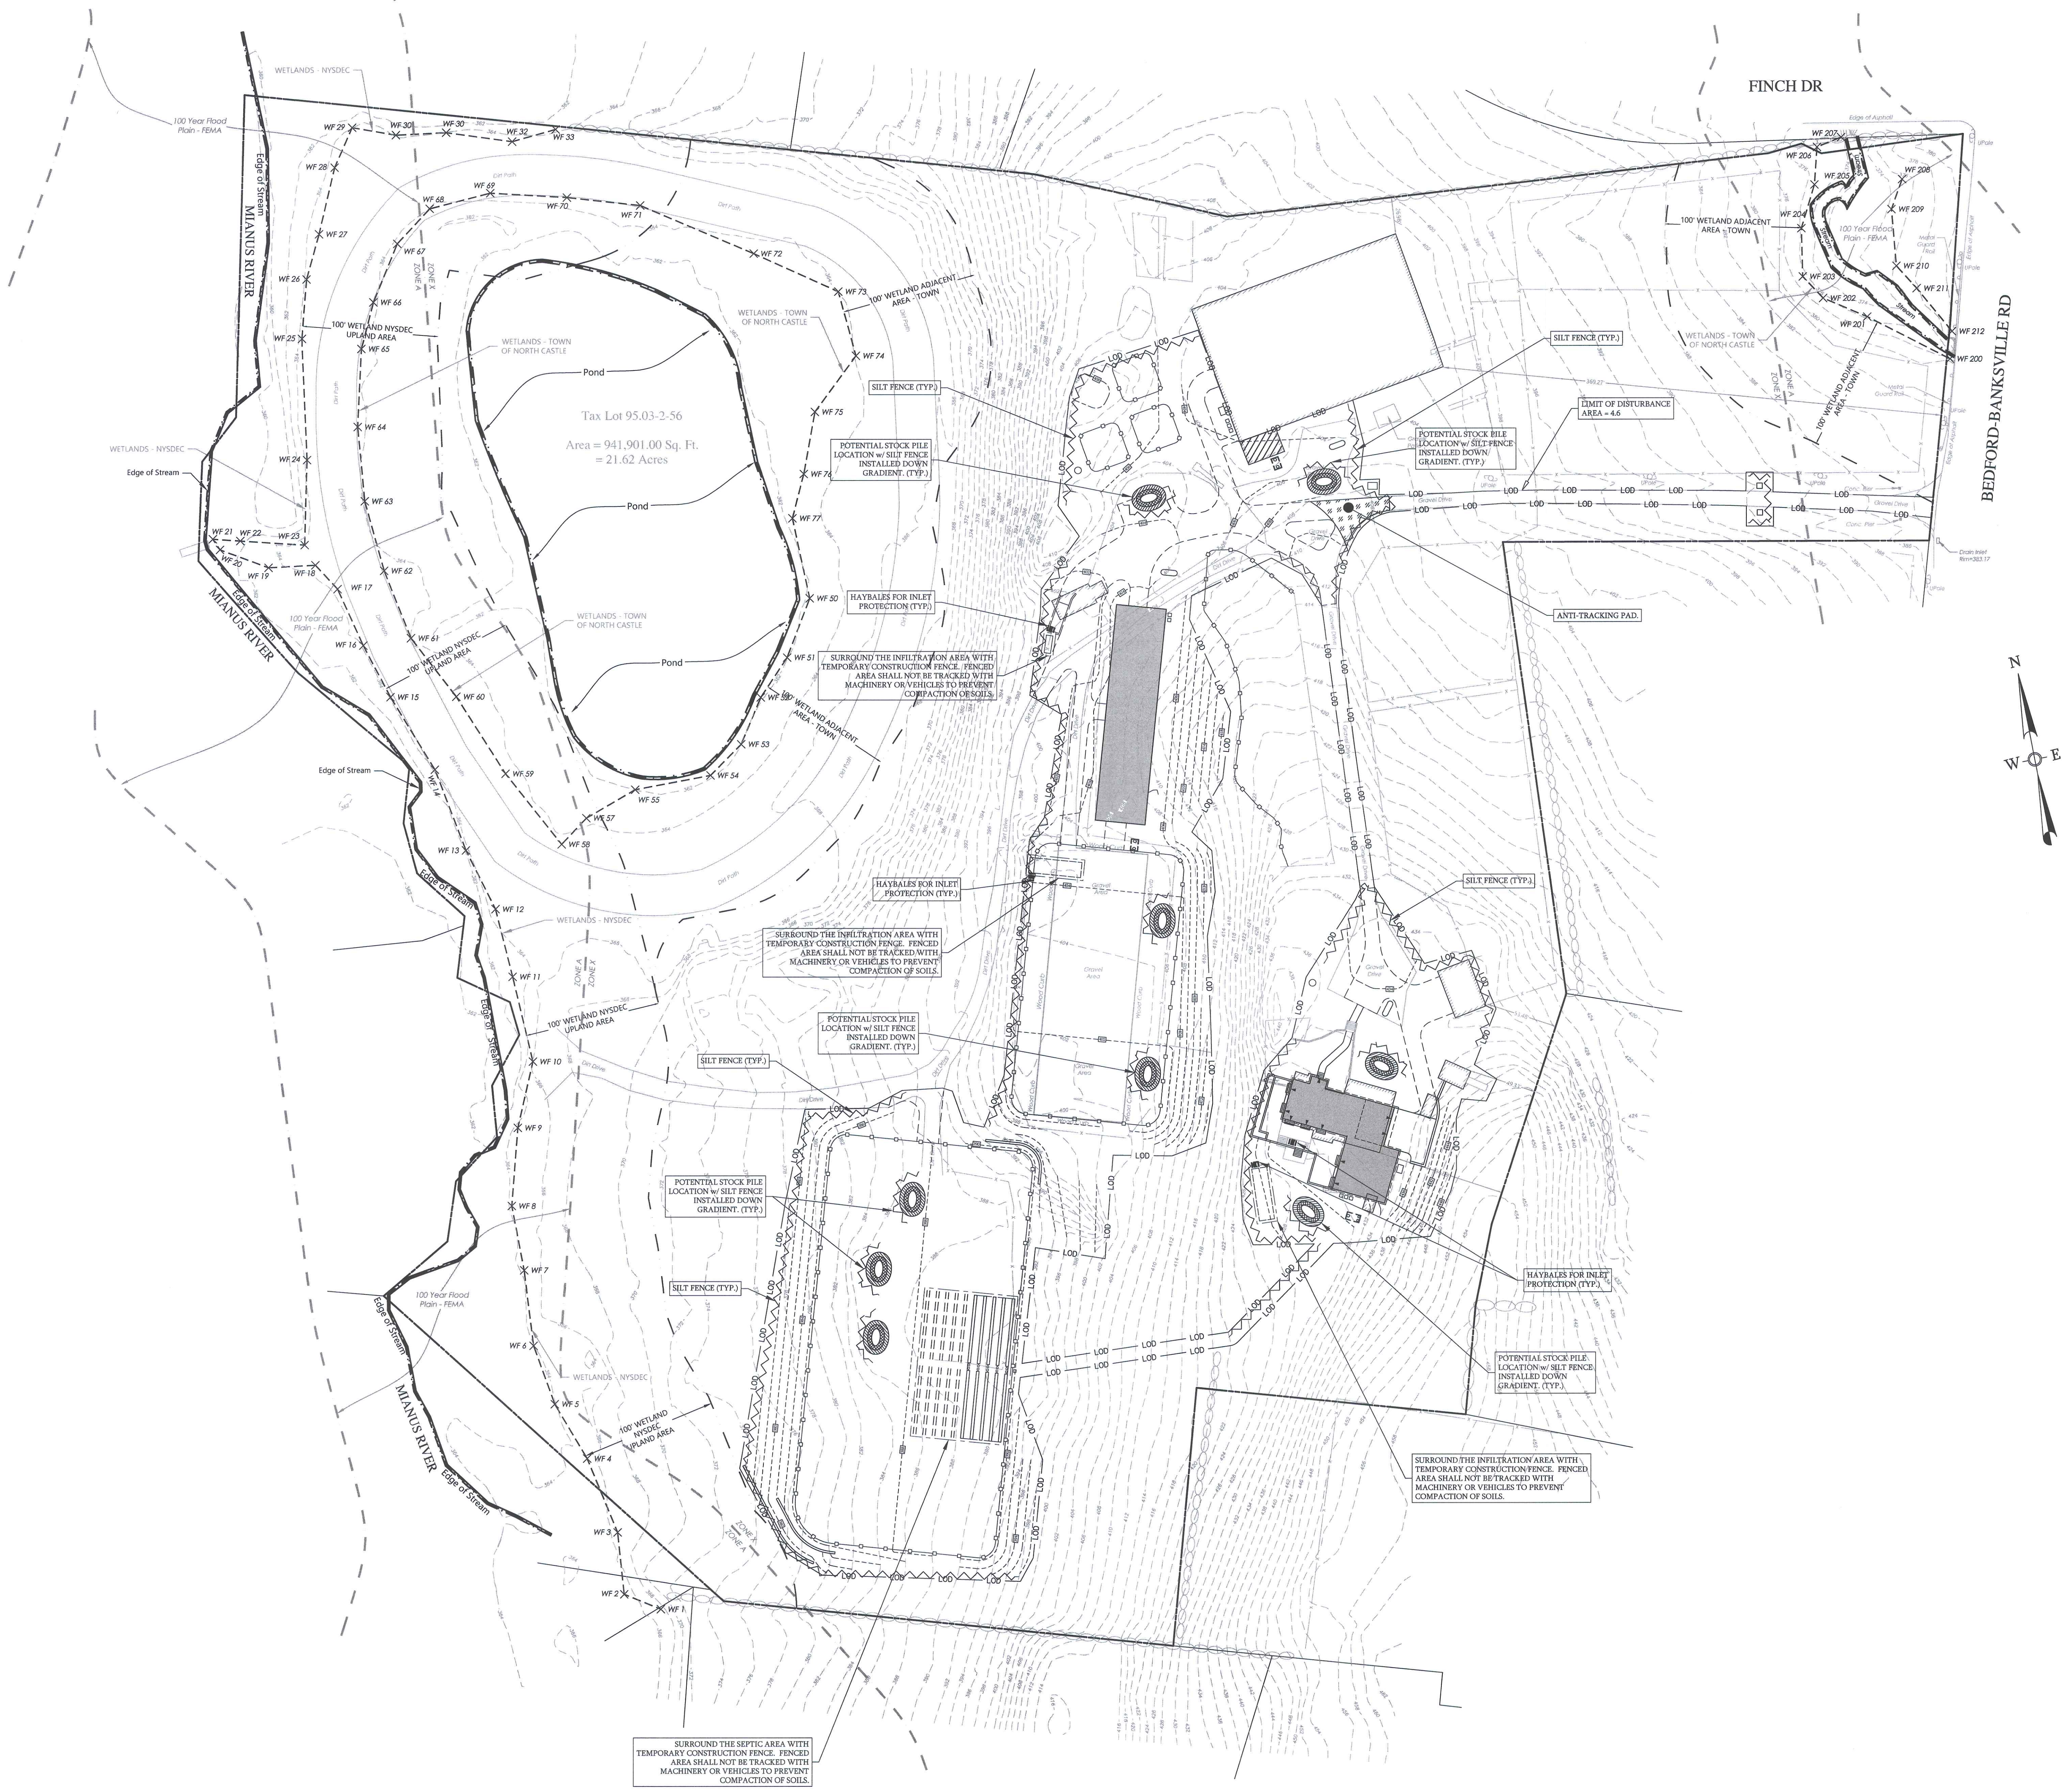
C-2B

EROSION & SEDIMENT CONTROL PLAN
 DEPICTING
263 BEDFORD BANKSVILLE ROAD
 BEDFORD, NY (NORTH CASTLE MUNICIPALITY)
 PREPARED FOR
KENT FARRINGTON LLC
