JAY FAIN & ASSOCIATES, LLC

Re: Special Use Permit/Site Plan Application, Additional Horses, 263 Bedford Banksville Road

On behalf of Kent Farrington LLC, we are pleased to submit a Special Use Permit Application/Site Plan Application for additional horses for property situated at 263 Bedford Banksville Road. In support of these Applications, we have attached the following supporting documents:

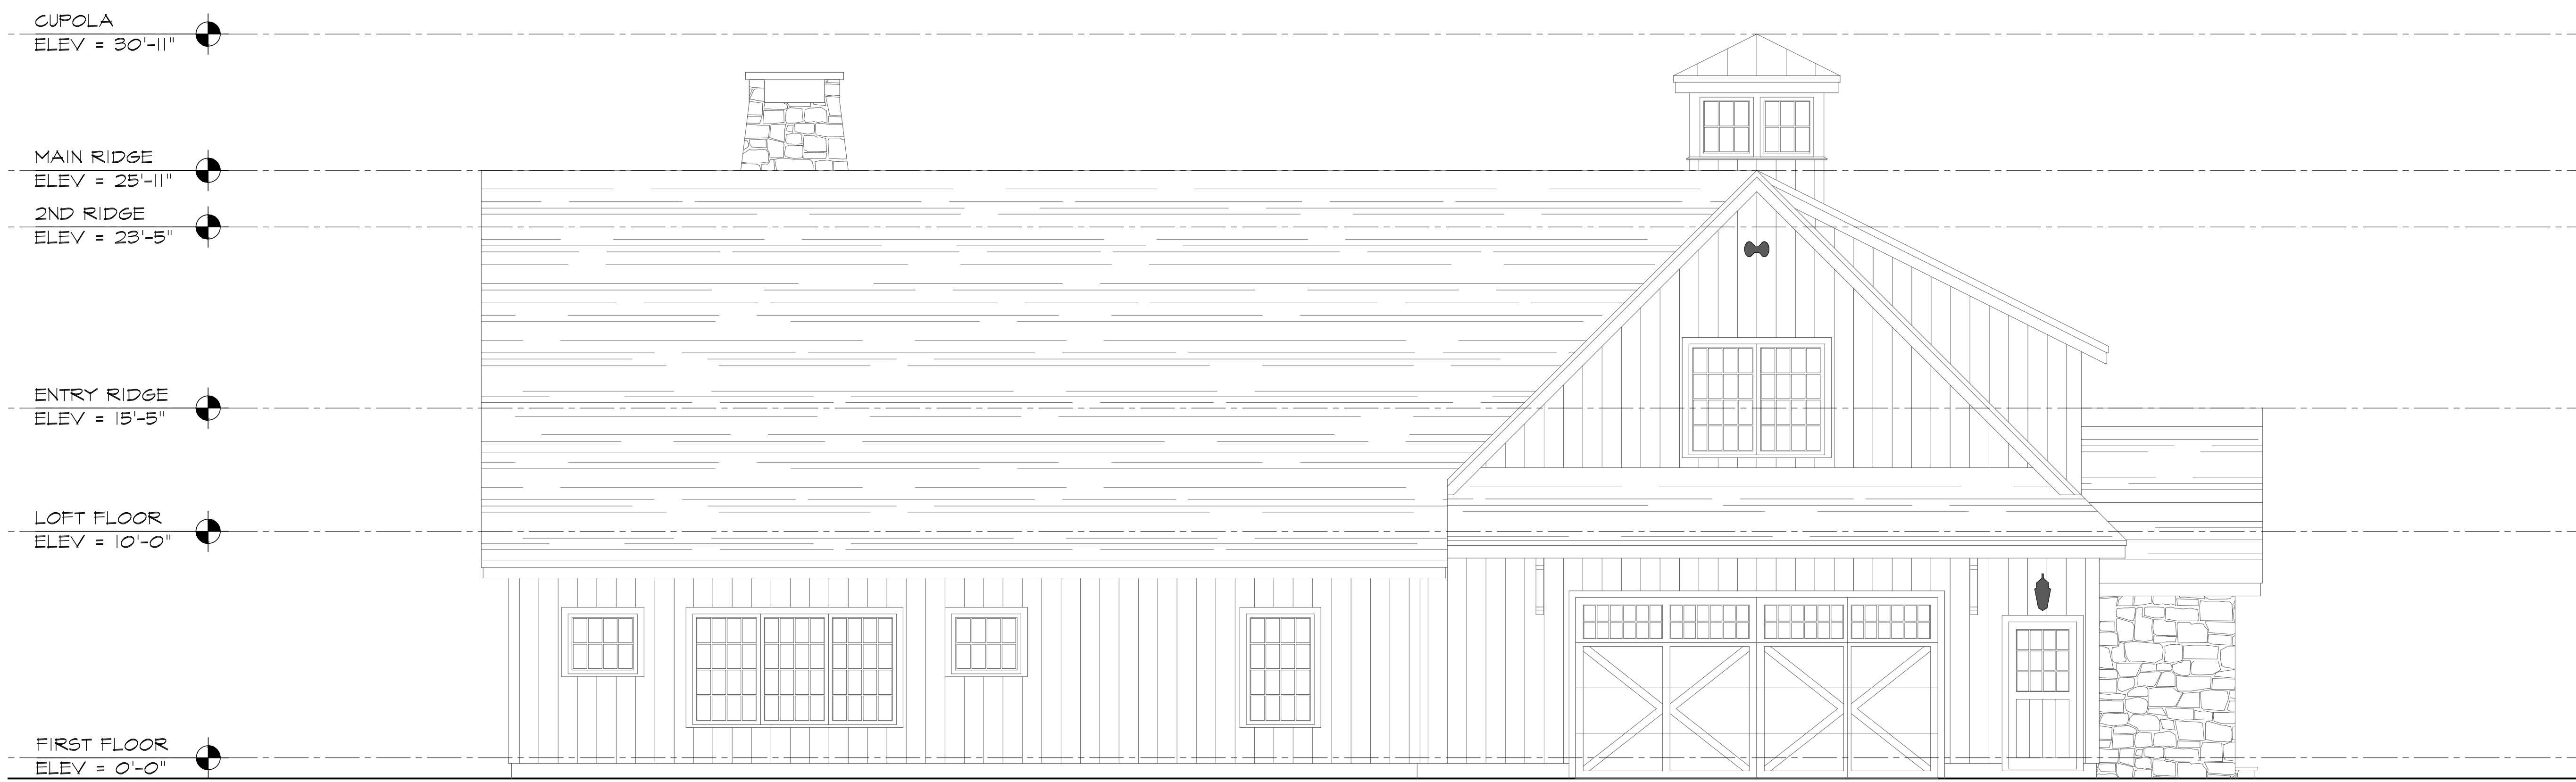
LEFT ELEVATION
SCALE: 1/4" = 1'-0"
